Municipality of Princeton
Preliminary Investigation Report
Non-Condemnation Area in Need of
Redevelopment
Block 31.01, Lot 105 and Block 7301, Lot 1

Topology, LLC
60 Union Street, 1st Floor
Newark, NJ 07105

Appendix F: Visual Survey Report

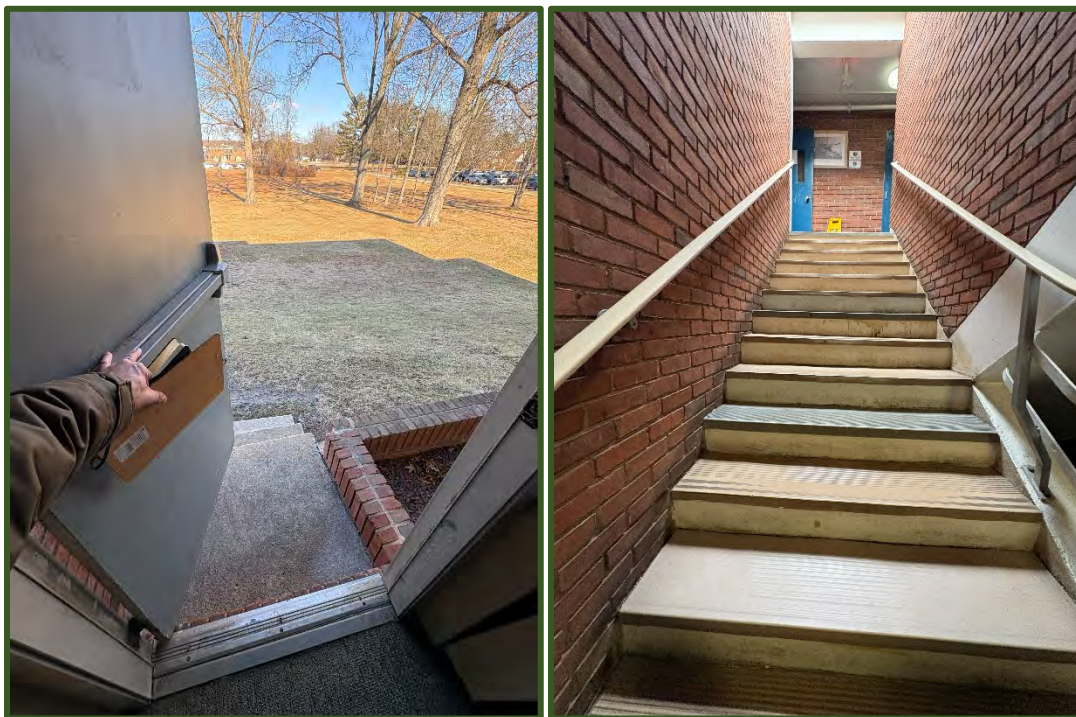
Figure 25 (left): Dorm exit, lacking accessibility features such as a hand railing.

Figure 26 (right): Dorm stairs which depict a lack of accessibility.

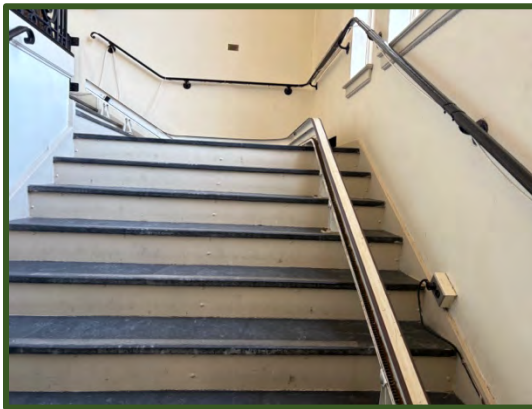
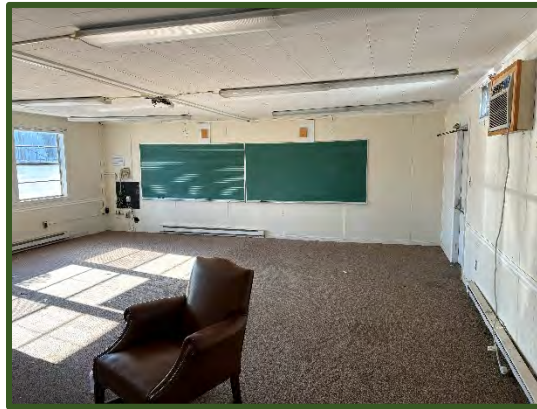
*Figure 28 (left): Chair lift depicted in Bristol Hall, not accessible for wheelchair users.
Figure 29 (right): Relocatable Classrooms, lacking in bathroom facilities.*

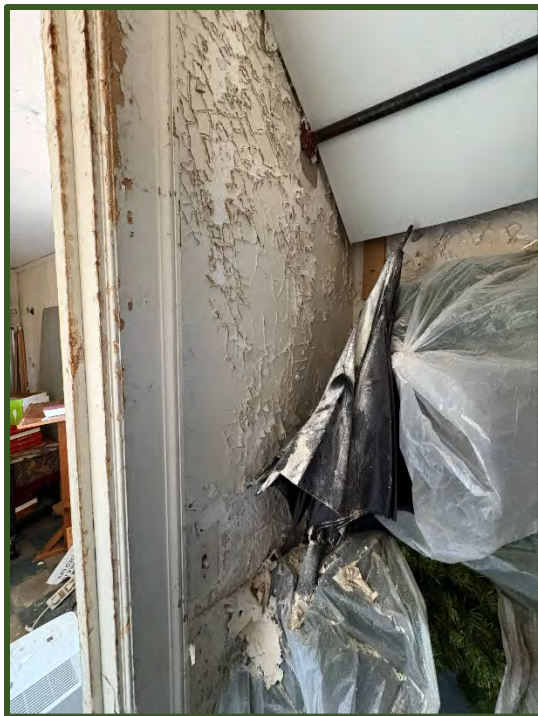
Figure 31 (left): Steam damage in Bristol Hall.

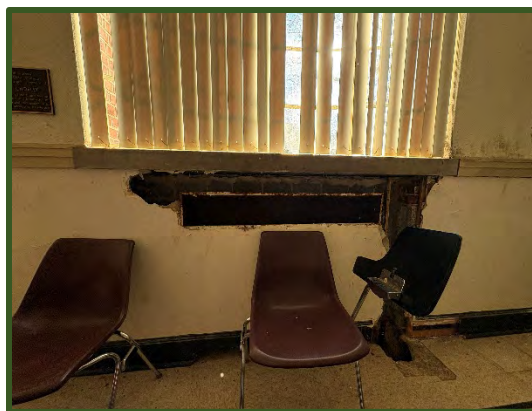
Figure 32 (right): Damaged wall and floor in Bristol Hall.

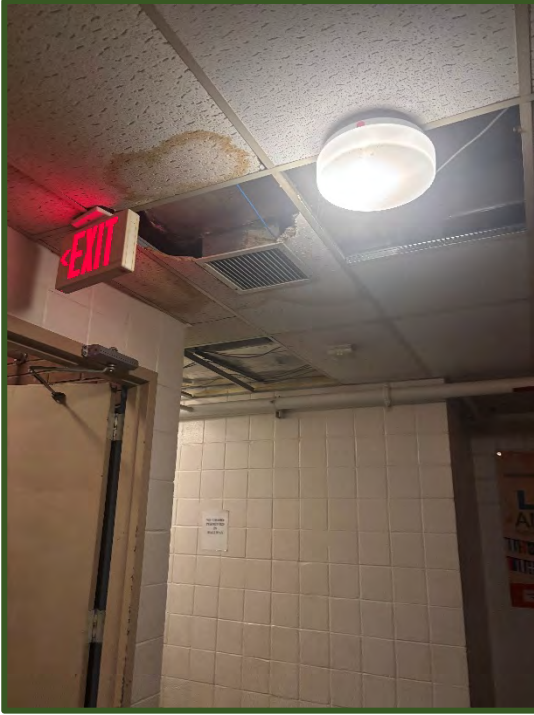
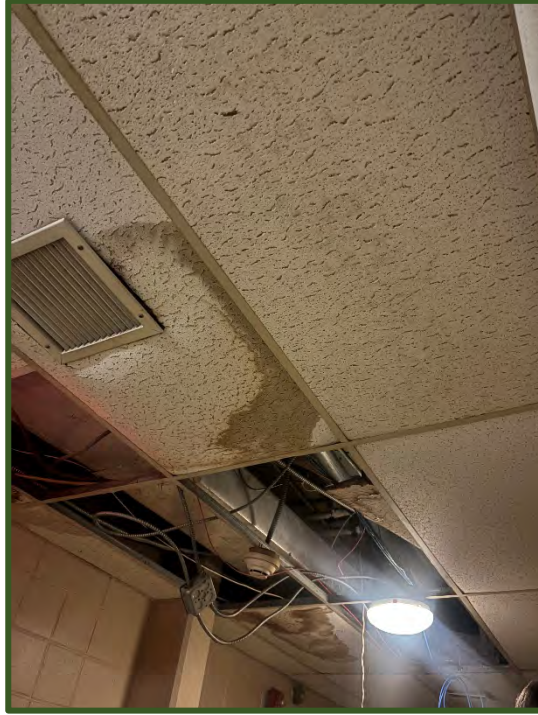
*Figure 33 (left): Leak causing stain on ceiling in Princeton Hall.
Figure 34 (right): Hole in ceiling depicting stain from leak in Ithaca Hall.*

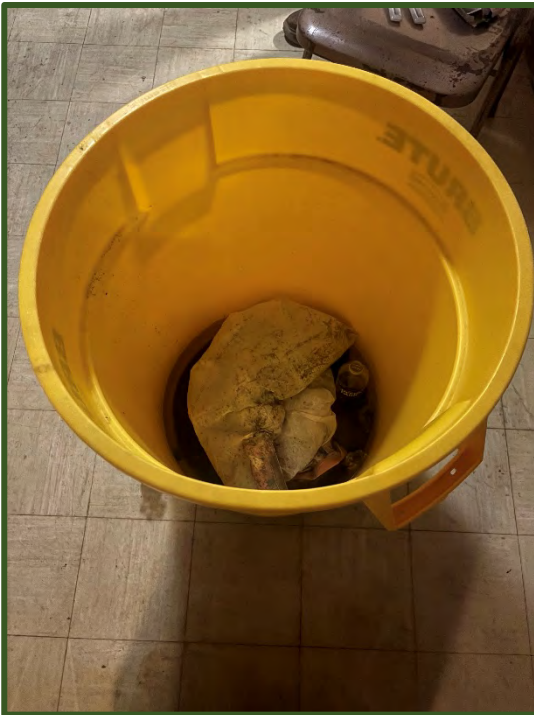
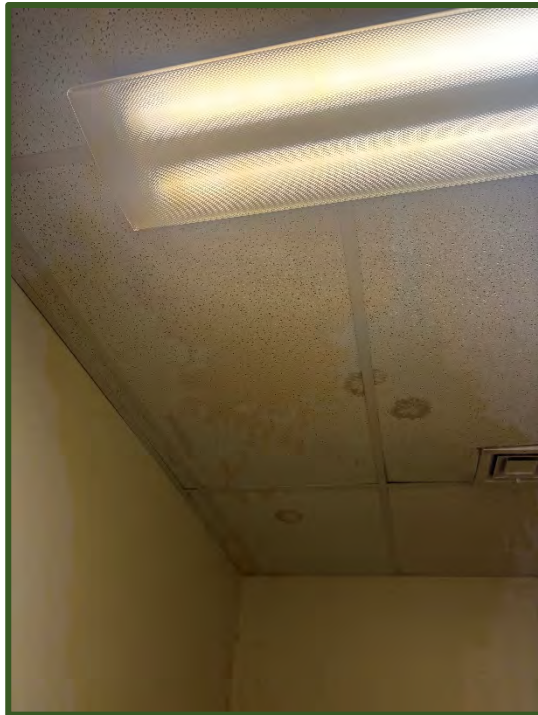
*Figure 35 (left): Bucket on the floor of Ithaca Hall due to leak from ceiling.
Figure 36 (right): Stains on ceiling of Ithaca Hall from a leak.*

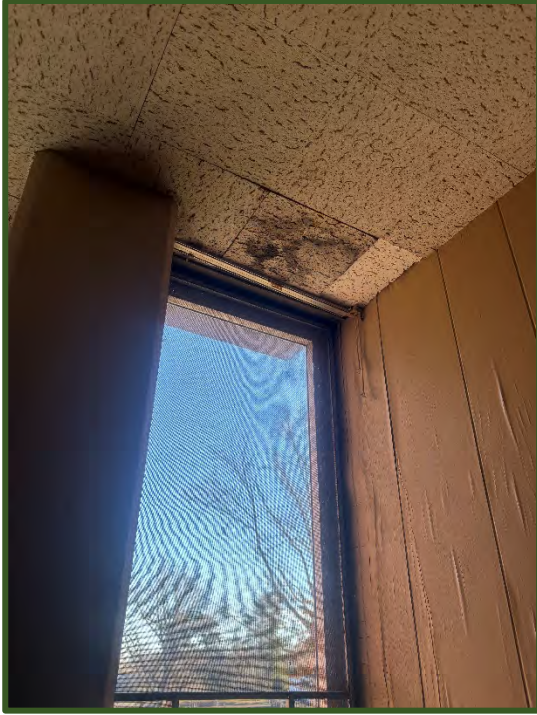
Figure 37 (left): Leak in ceiling in Dayton Hall.

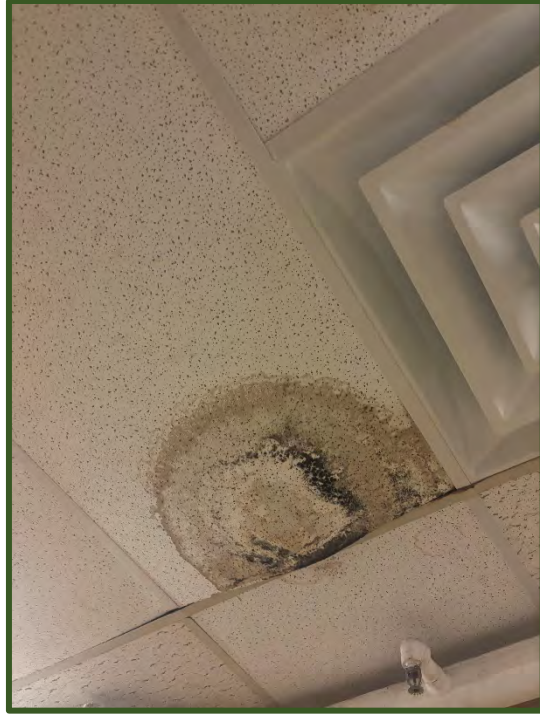
Figure 38 (right): Mold-like substance on the ceiling of Ithaca Hall due to leak from ceiling.

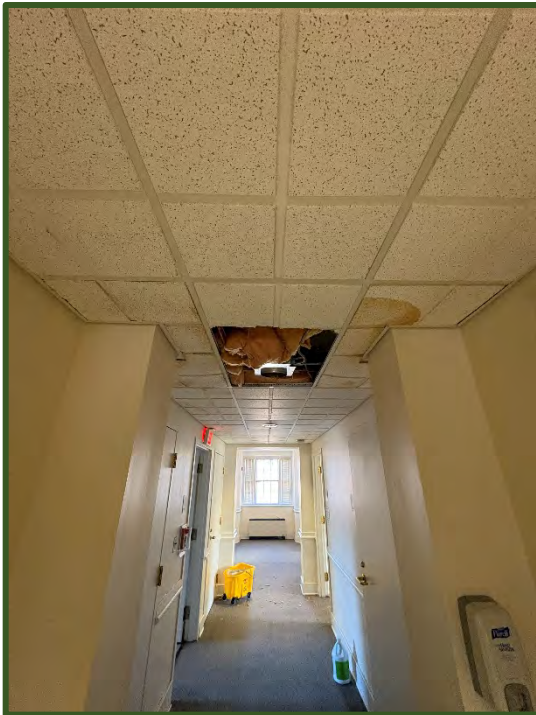
Figure 39 (left): Hole and stain from leak in ceiling of Erdman Hall.

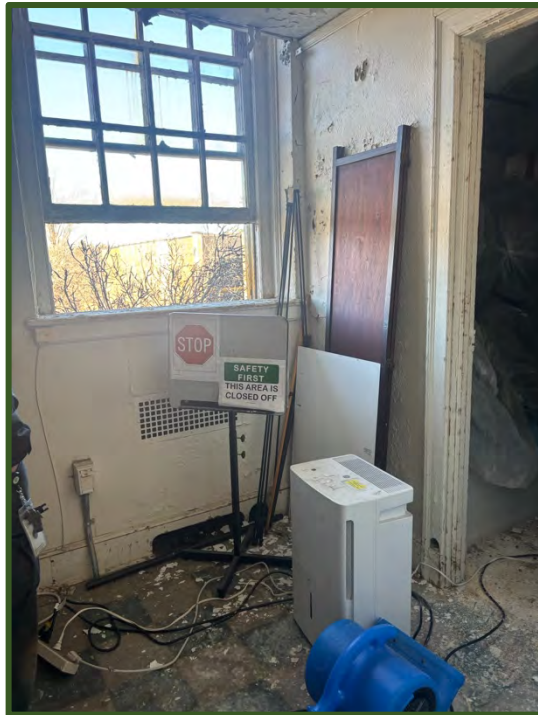
Figure 40 (right): Steam damage in Bristol Hall.

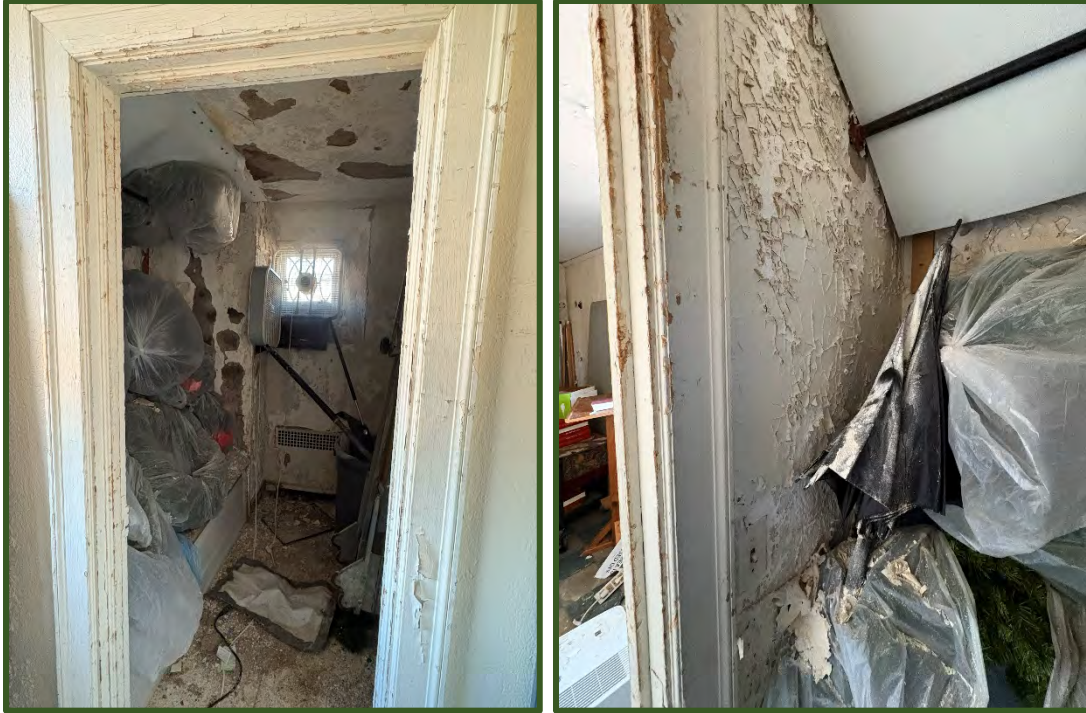
Figure 41-42: Steam damage depicted in Bristol Hall.

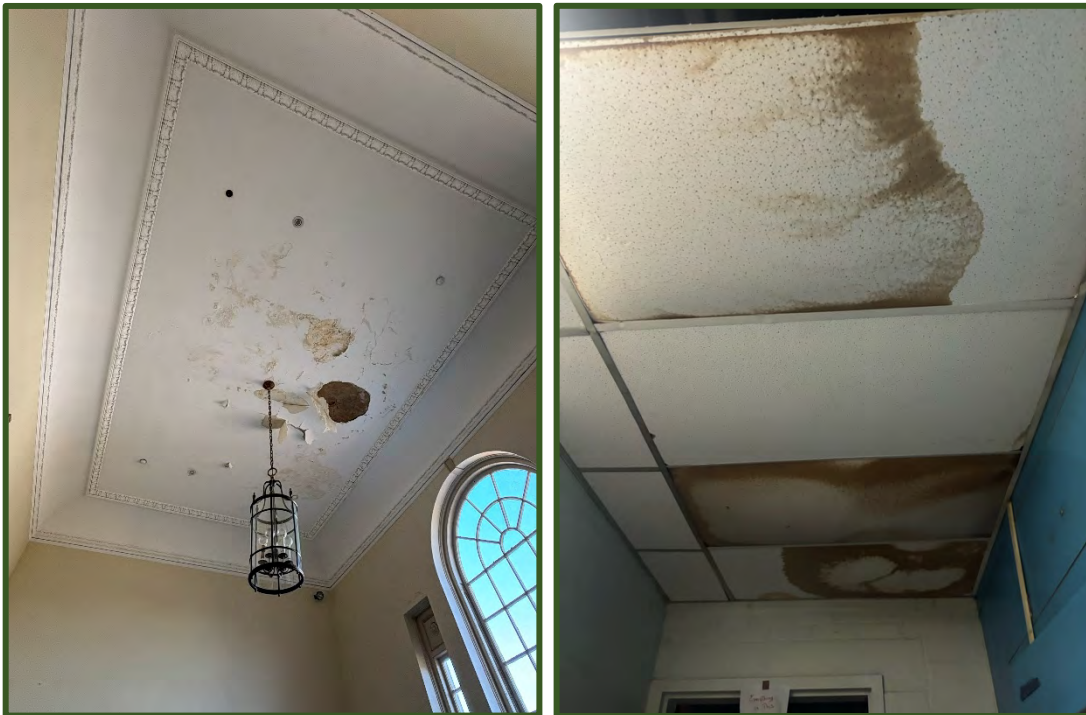
Figure 43 (left): Damaged plaster on the ceiling of Bristol Hall.

Figure 44 (right): Water damage in the Student Center

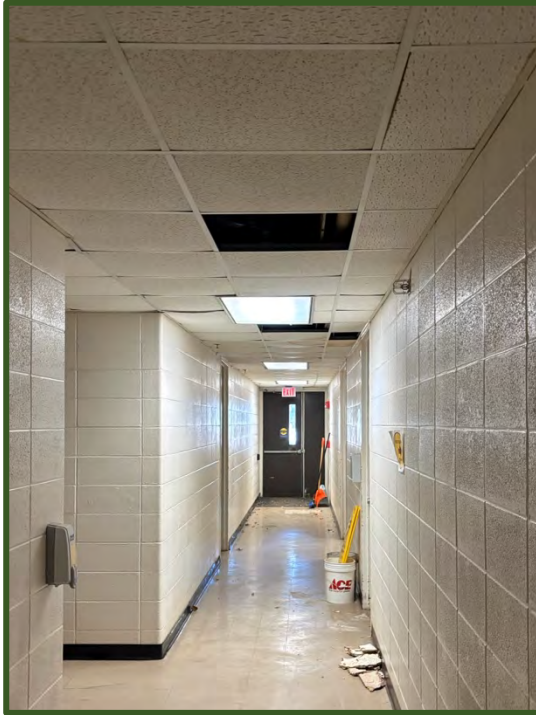
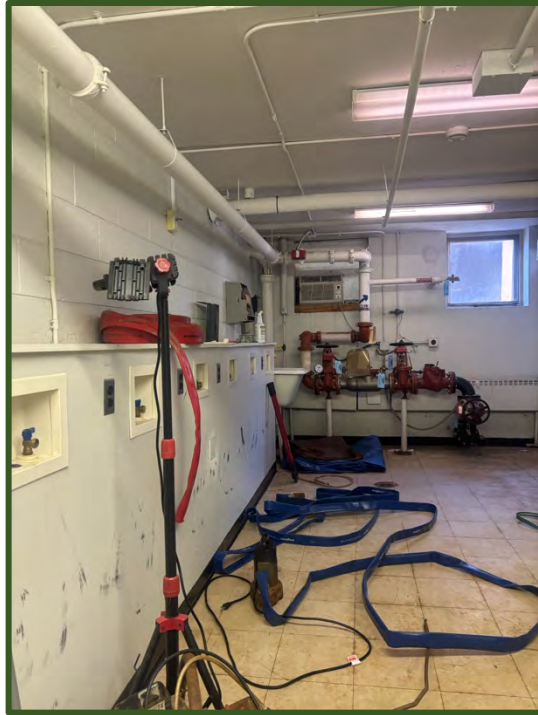
Figure 45 (left): Water damage alongside damaged plaster in Talbott Library

Figure 46 (right): Sprinkler system depicted in Seabrook Hall, depicting sprinkler system which is currently not functioning following basement flooding

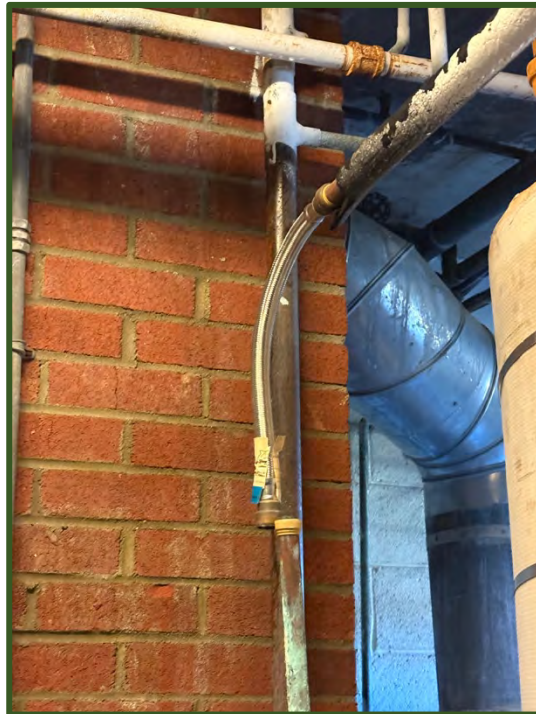
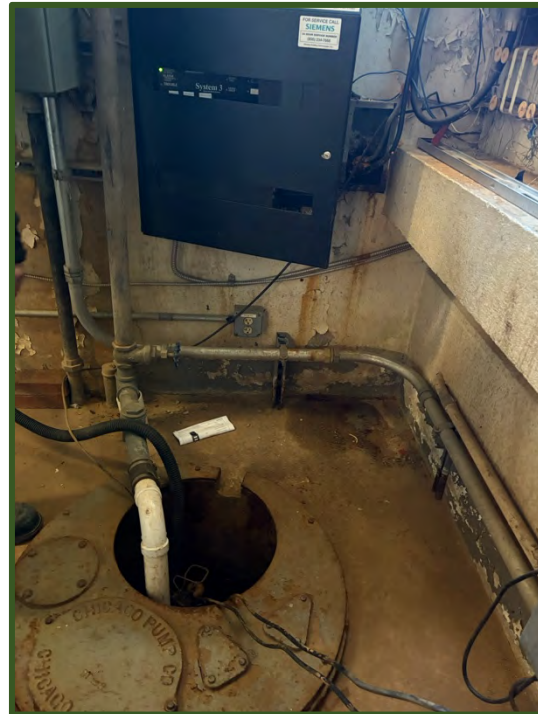
Figure 47 (left): Burst pipe that caused flooding in Seabrook Hall

Figure 48 (right): Water damage depicted in basement of Seabrook Hall following flooding

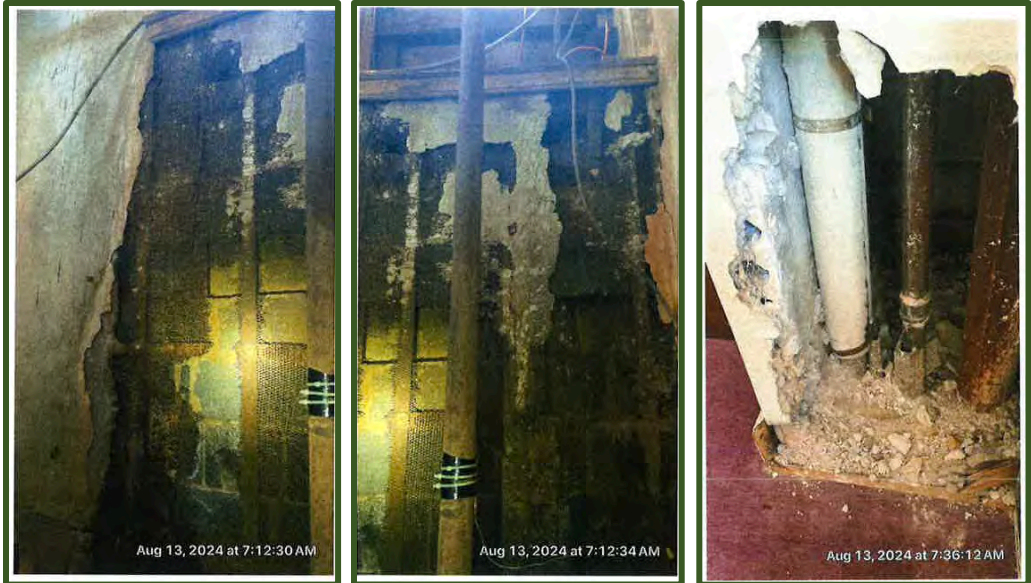
Nowhere within the Study Area is the threat of water more apparent than in Taylor Hall. No entry to this building is permitted due to the impacts of a major steam leak in January 2024. As a result, no interior inspection was conducted for this study. EWMA, an environmental remediation and consulting firm, however, was contracted by the municipality to conduct a visual survey of the building (the “EWMA Report”, included in Appendix F). Based on their report, “the steam appeared to affect the integrity of...building materials on the first and lower floors” and “there were significant amounts of mold visible throughout these areas as well...”¹⁰

Figures 49-51: Images of significantly damaged materials within Taylor Hall, both finishing and structural, resulting from water damage¹²

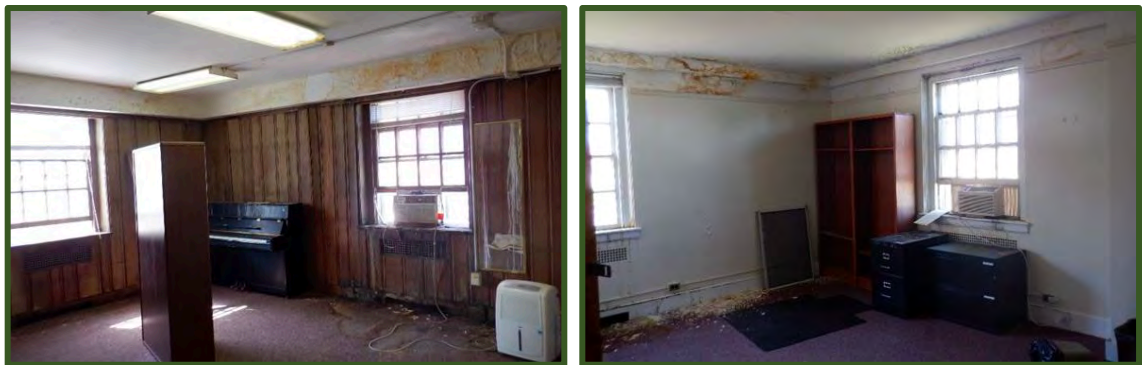
Figures 52-53: Steam damaged room in Taylor Hall¹³

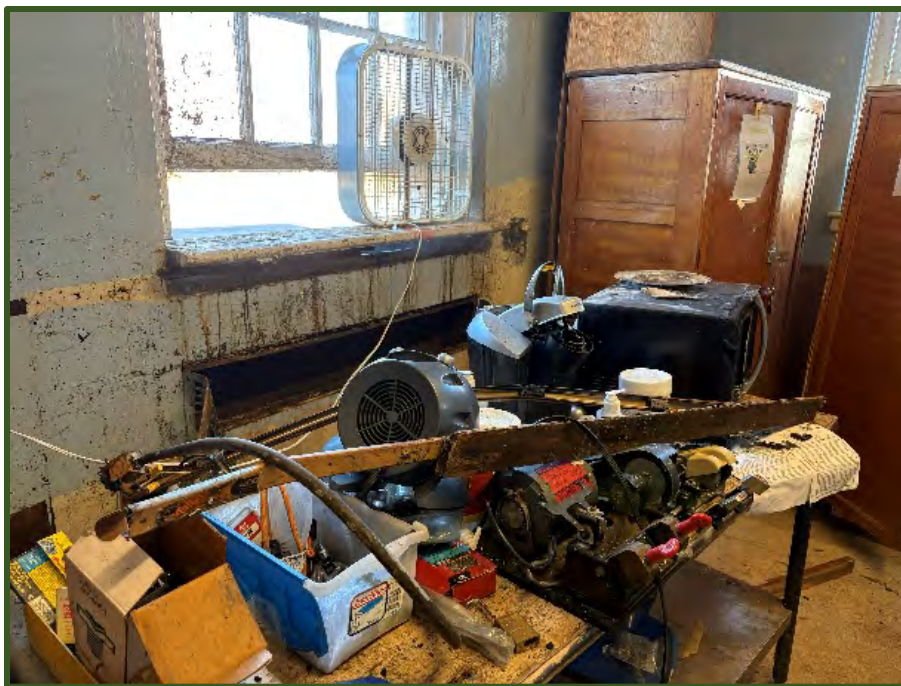
Figure 54: Evidence of fire related to the steam heating system that started on top of microwave in Bristol Hall.

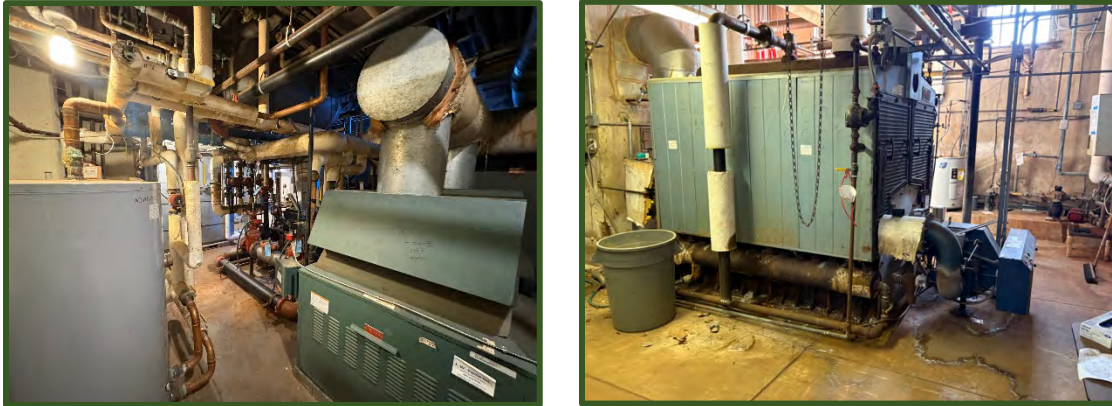
system issues with the boilers, which include “[a] steam distribution leak between buildings” and “limited system accessibility”.

Figure 55 (left and right, above): System which services Dayton, Princeton and Ithaca Halls.

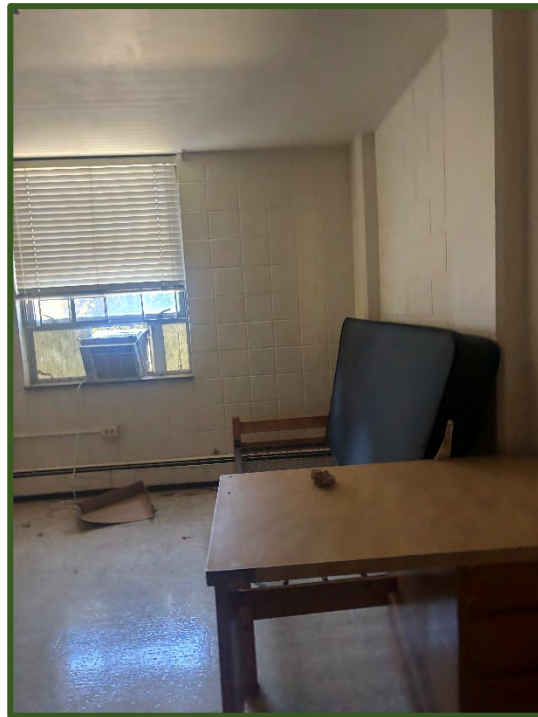
Figure 56: Lack of central air conditioning in Dayton Hall, with built-in wall unit.

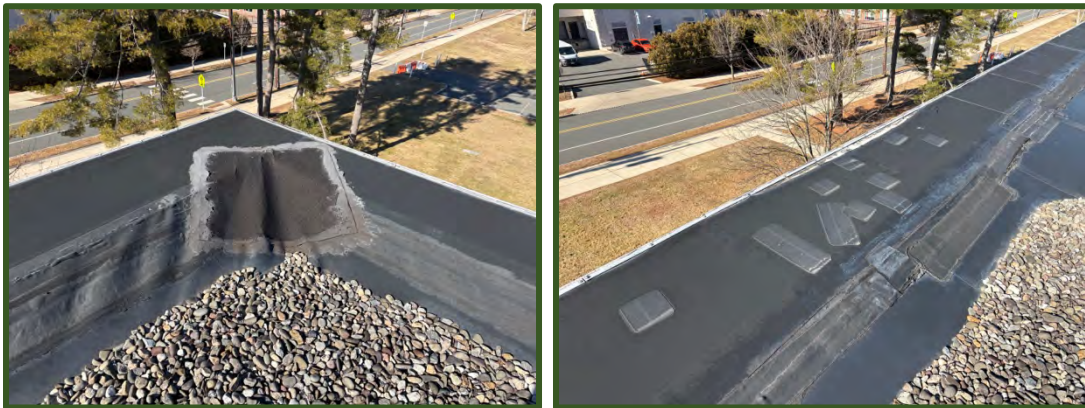
Figure 57-58 Seabrook Hall depicted, with patches and loose gravel which signify poor roof conditions²⁴

²⁴ These conditions are indicative of prior complications with a roof such as leaks and wear and tear due to age. These issues contribute to difficult regulating indoor heating and cooling systems. What issues should I look out for on my flat roof? Rolling Hills Roofing. <https://www.rollinghillsroofing.com/roof-tips/common-flat-roof-problems>. Accessed March 11, 2026.

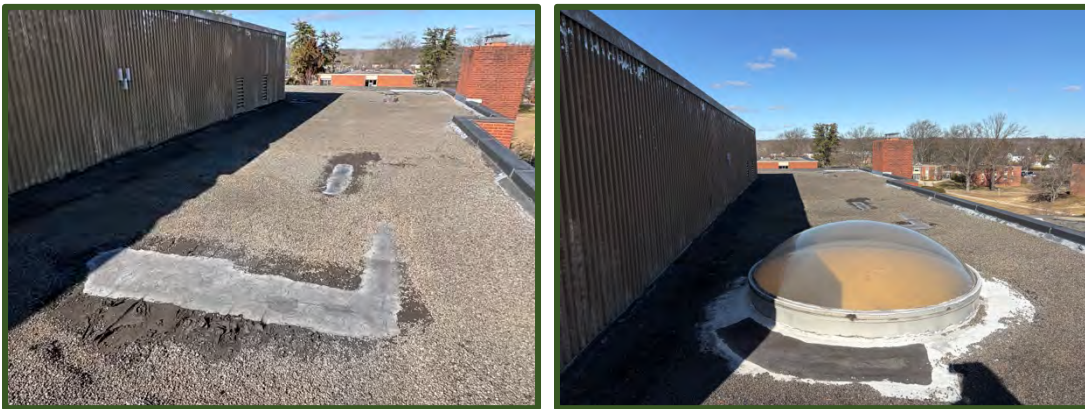
Figures 59-60: Roof of Student Center, depicted patches which signify poor roof conditions

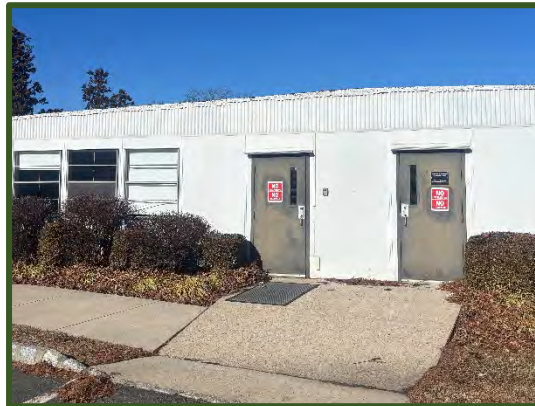
Figure 61: Relocatable Classrooms depicted, currently with a temporary roof that needs to be replaced.

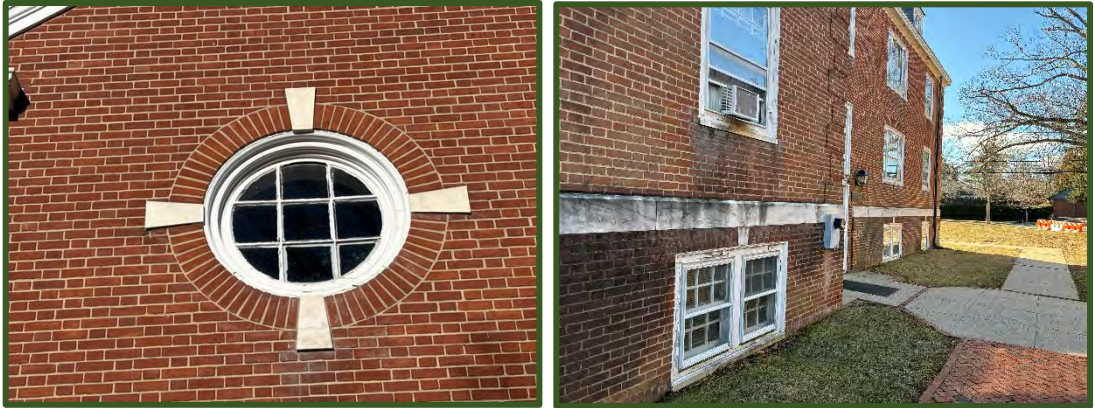
Similarly, rotting window frames interfere with the buildings' ability to maintain and regulate indoor temperatures. Rotted window frames were observed in several of the buildings during the January 15th site visit, including Erdman Hall, Taylor Hall and Bristol Chapel. Rotted window frames cause gaps and air leaks which allow both hot and cold air to enter buildings. According to the U.S. Department of Energy, heat gain and heat loss from windows account for roughly 25%-30% of heating and cooling energy use.²⁵ These conditions are particularly true when single-paned windows are used, as is the case throughout many of the Study Area buildings. The substantial energy loss from substandard windows directly contributes to the overall poor functioning heating and cooling systems throughout the Study Area.

*Figure 62 (left): Exterior rotted window at Bristol Hall.
Figure 63 (right): Exterior rotted windows in Erdman Hall.*

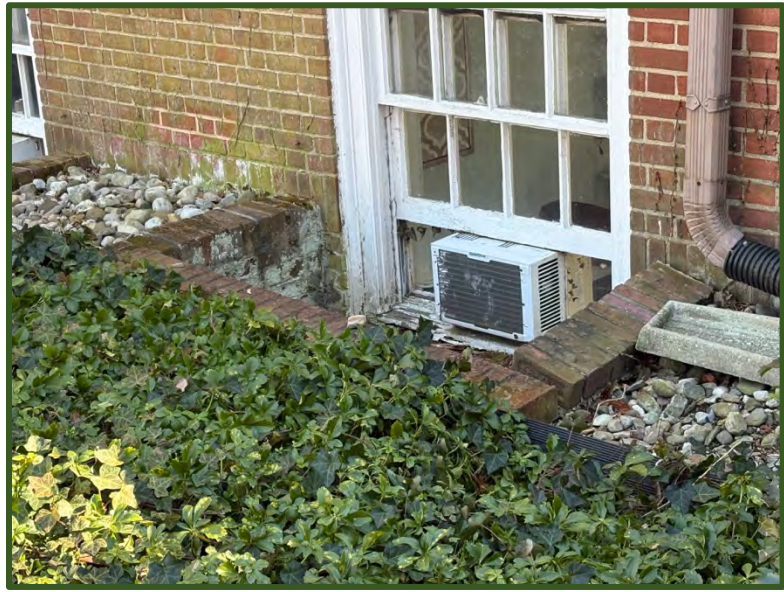
Figure 64: A window well in Williamson Hall depicted in dilapidated condition

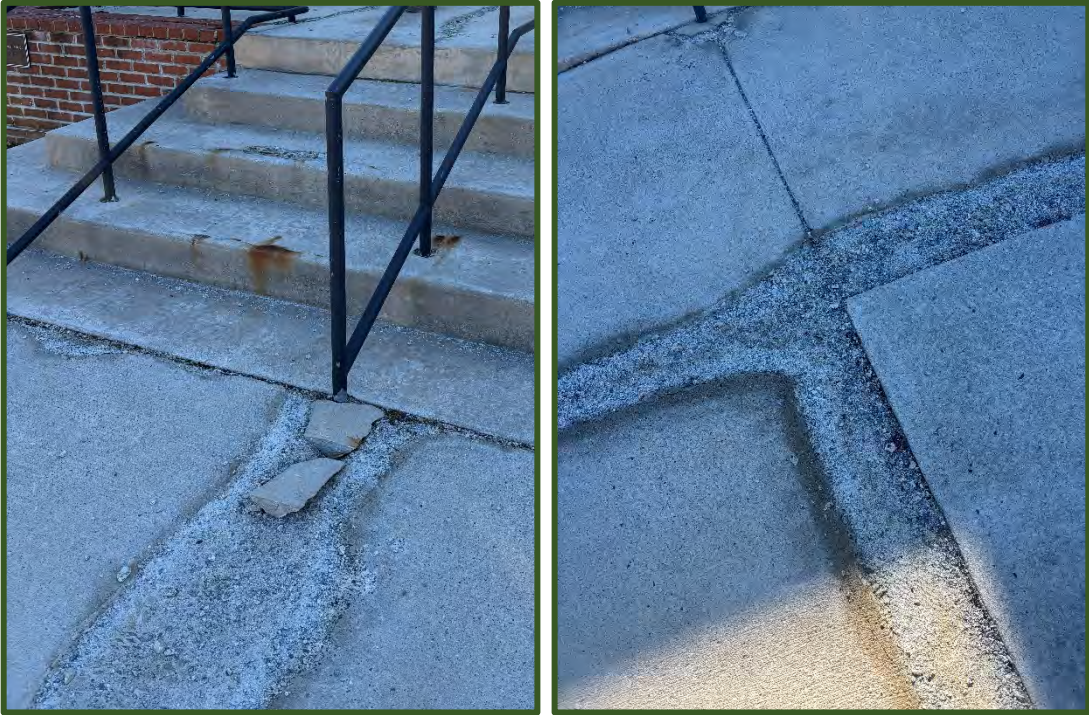
Figure 65-66: Cracked sidewalk outside of Hillman Hall and the Playhouse.

These dilapidated improvements are detrimental to public safety and welfare. Sidewalks and pathways which are crumbling, cracked and uneven significantly increase the risk of injuries and limit accessibility.³² While it is inevitable for the quality of sidewalks to erode over time, the key to ensuring the best possible safety outcomes for pedestrians is continuous maintenance.

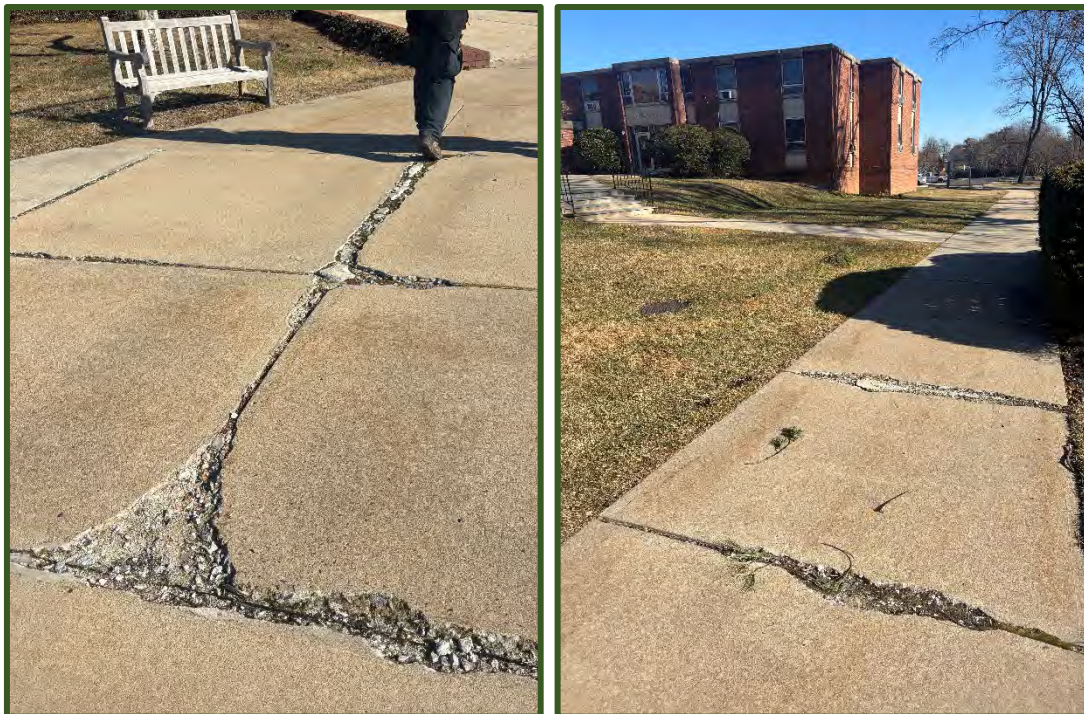
*Figure 67 (left): Cracked sidewalk outside of Talbott Library.
Figure 68 (right): Cracked sidewalk outside of dorm buildings.*

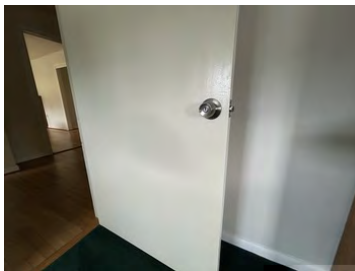
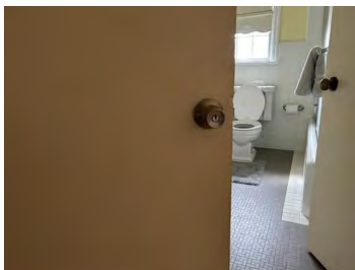
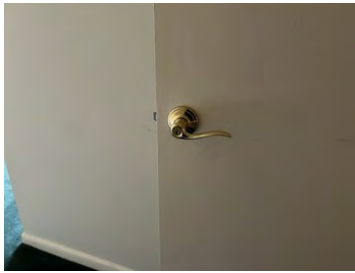
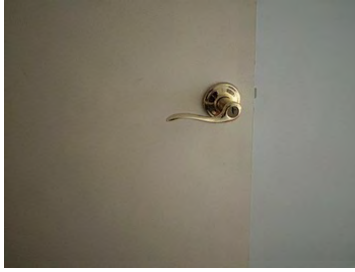
The bedroom doors were equipped with locking devices that allow the doors to be locked when the bedrooms are not occupied. This is prohibited by the Housing Code. Replacement of these locks is required.

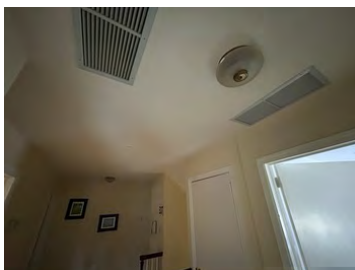
Hallway lights on the 2nd floor were inoperable at the time of inspection. All artificial lights shall be operable for safety reasons. Repair is required per the Housing Code.

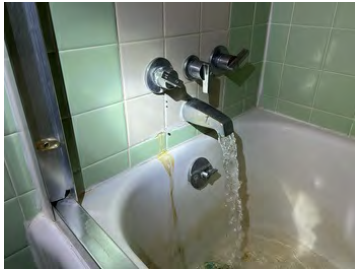
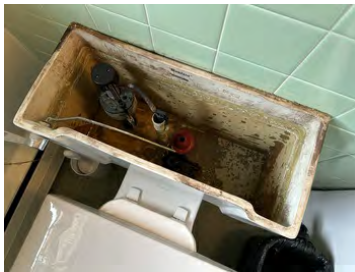
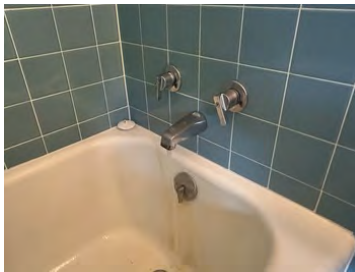
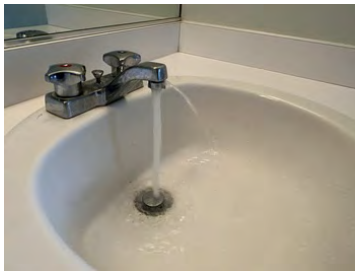
Plumbing fixtures in the 2nd floor bathrooms were in a general state of disrepair at the time of inspection. Faucet handles leaked and were loose, a toilet flapper was damaged, and a faucet aerator sprayed water outside of the sink. Repairs are required per the Housing Code to restore proper function of the fixtures and prevent damage from moisture.

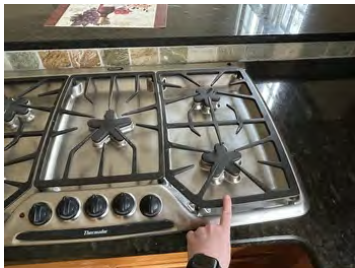
The gas stovetop front right burner was inoperable at the time of inspection. The stove burner should ignite without the need for any additional tools or aids aside from the stove igniter. Repair is required per the Housing Code to restore proper function of the burner.

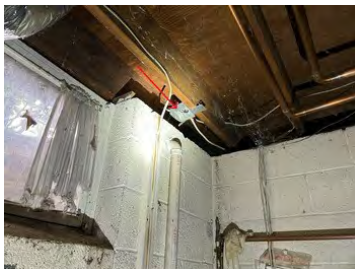
An open junction box or open wire splice was noted in the basement above the water heater at the time of inspection. This is prohibited and requires repair per the Housing Code for electrical safety reasons.

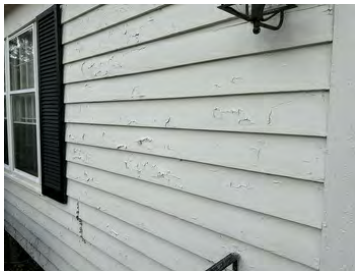
Chipped/peeling paint - Deteriorated paint, chipped, and/or peeling paint observed on exterior areas of the siding, window and door trim, entry and garage doors, and windows (wells/jambes/muntins). This is a lead paint hazard and requires repair.

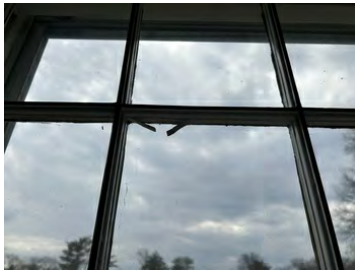
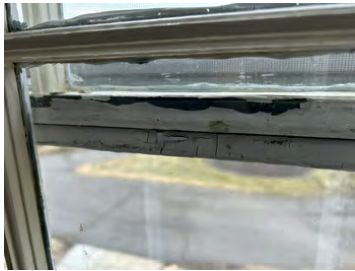
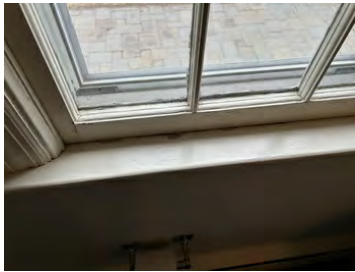
Chipped/peeling paint - Deteriorated paint, chipped, and/or peeling paint observed on interior areas of windows (sashes/sills/muntins). This is a lead paint hazard and requires repair.

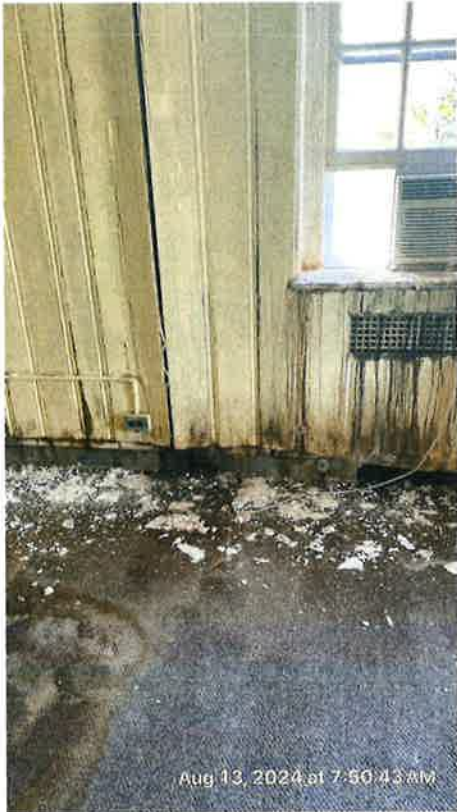
Taylor 2F office (from steam damage)

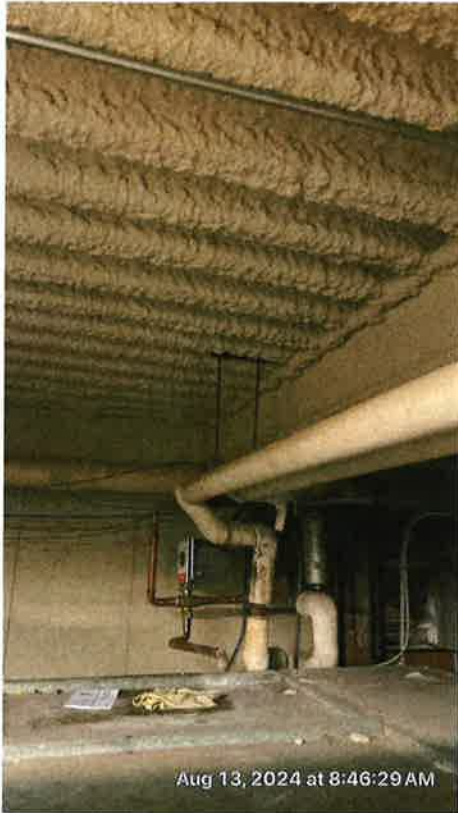
Student Center - fireproofing throughout (good condition)

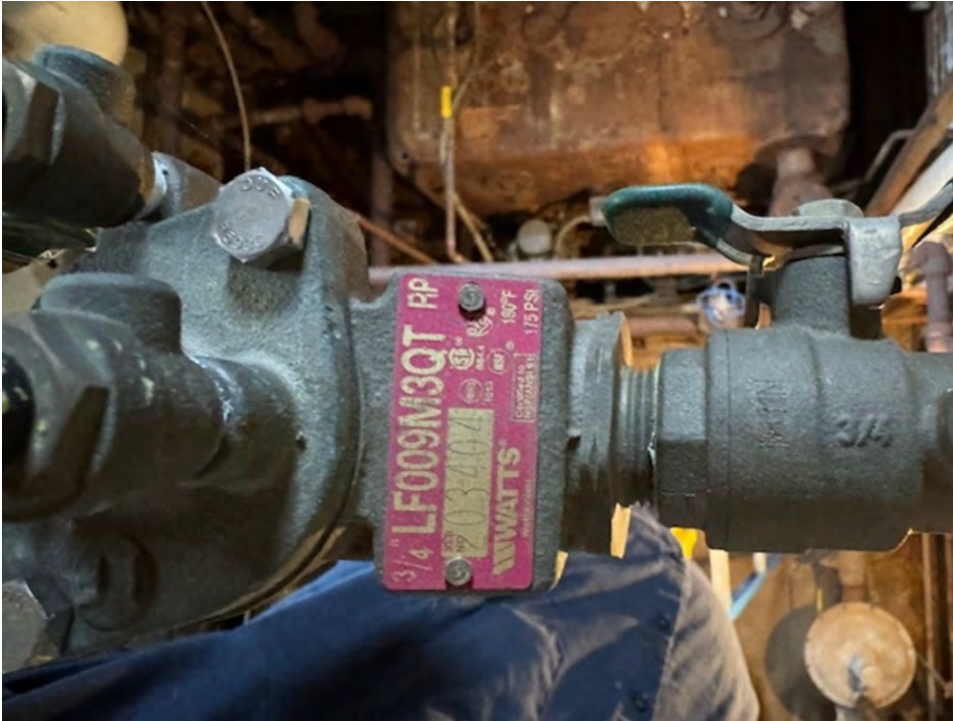
Backflow Preventer - Passed Certification

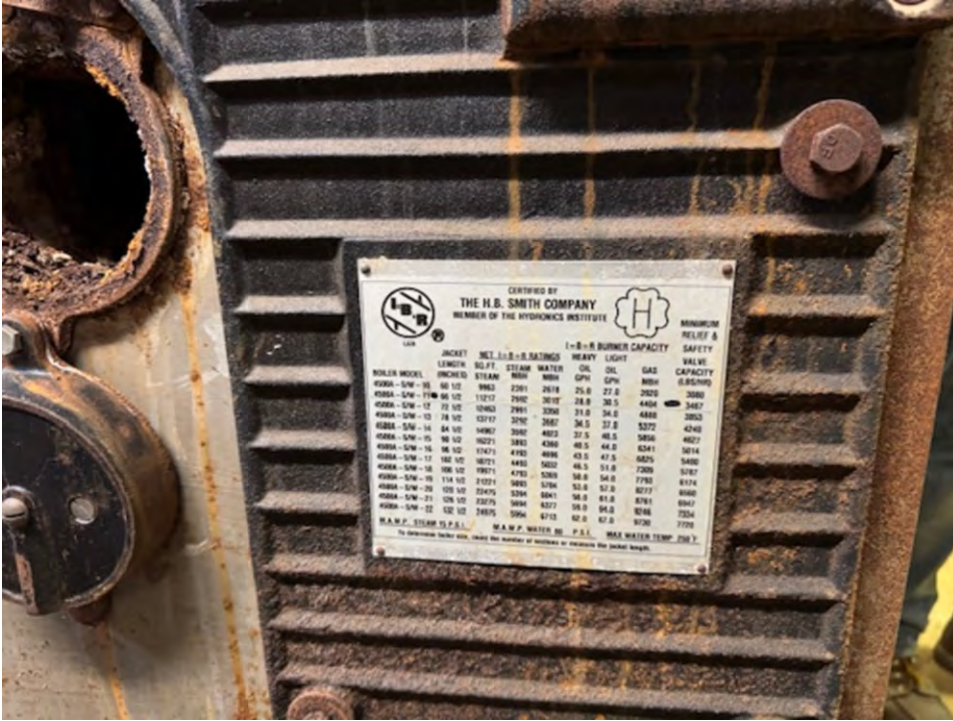
Boiler #1 Section Failure - Unit Offline

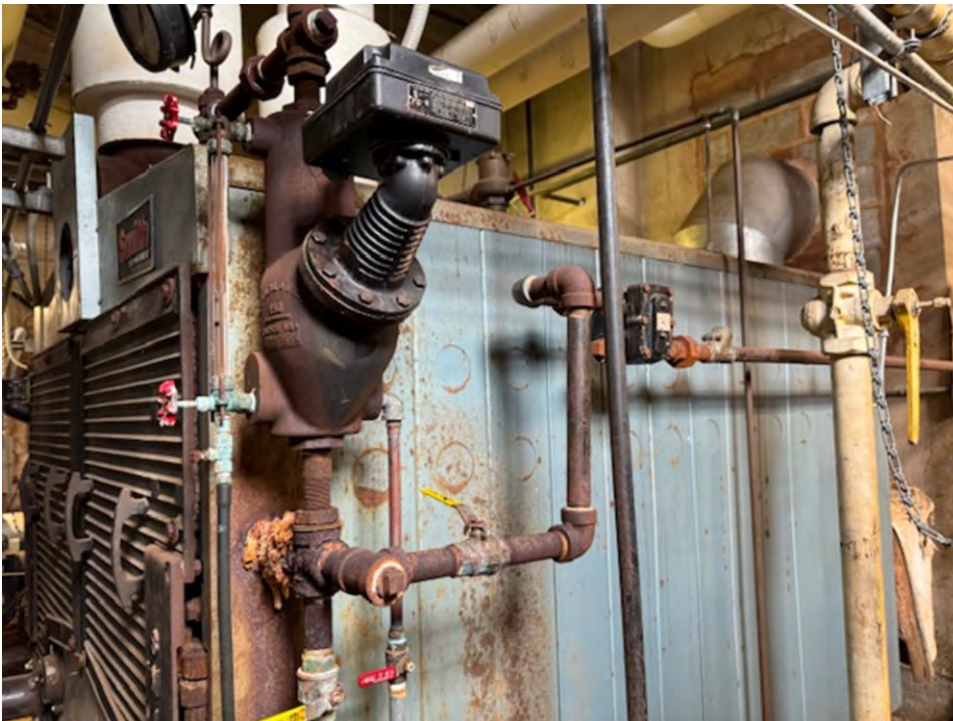
Boiler #2 Water Column - Replacement Required

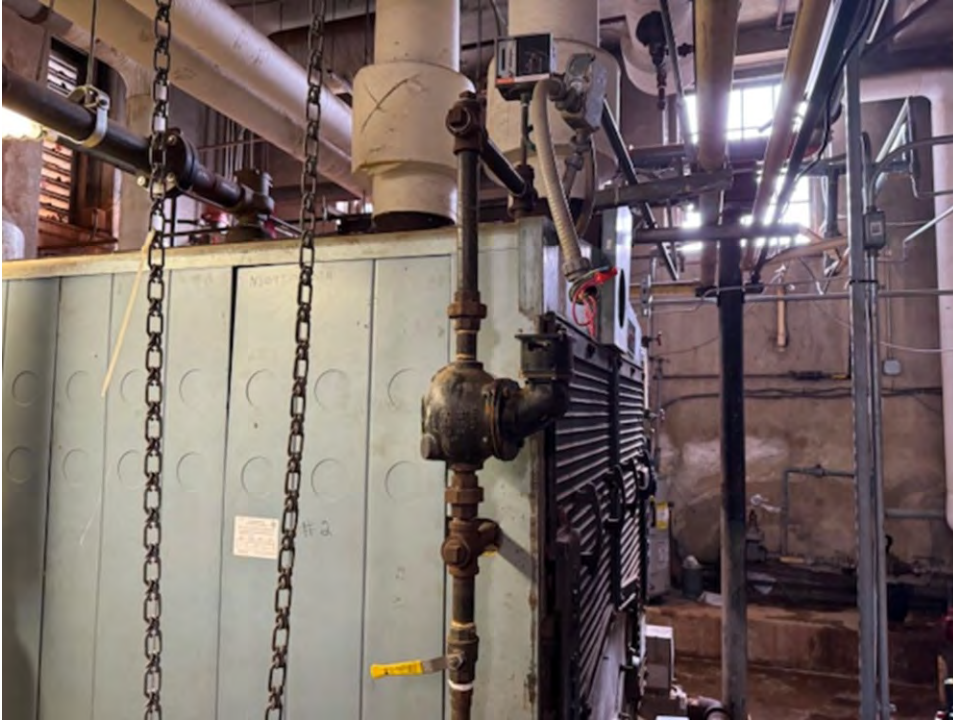
Boiler #2 LWCO Head - Replacement Required

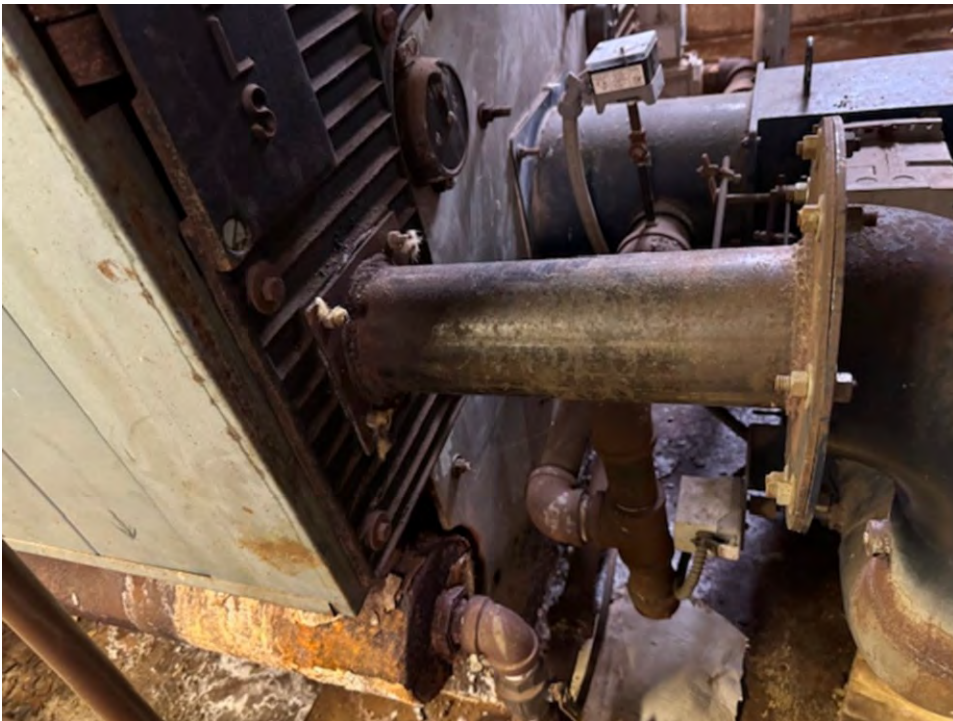
Boiler #2 FGR Piping - Improper Installation

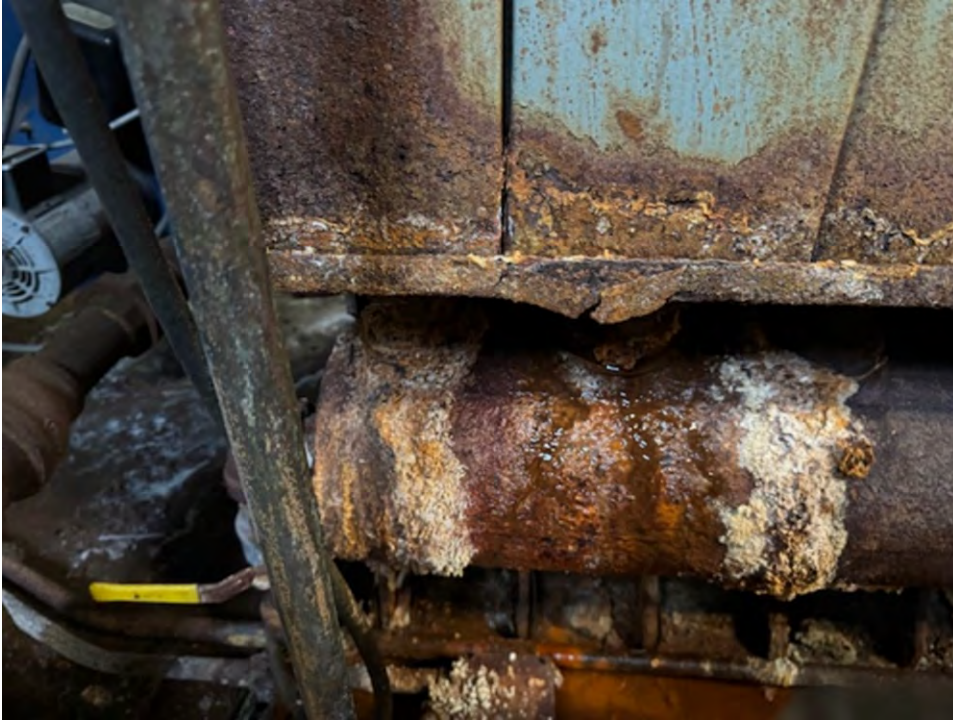
Boiler #2 Mud Drum Leaks - Multiple Failures
