# TREE MANAGEMENT PLAN FOR MARQUAND PARK, PRINCETON NJ

*Prepared for:*  
**The Marquand Park Foundation**  
**Pam and Roland Machold**  
**713 Prospect Ave**  
**Princeton, NJ 08540**

*Prepared by:*  
**Morris Arboretum**  
**UNIVERSITY of PENNSYLVANIA**  
*Official arboretum of the Commonwealth of Pennsylvania*  
*100 East Northwestern Avenue*  
*Philadelphia, PA 19118*  
*215 247-5777 extension 189*

**May 23, 2014**

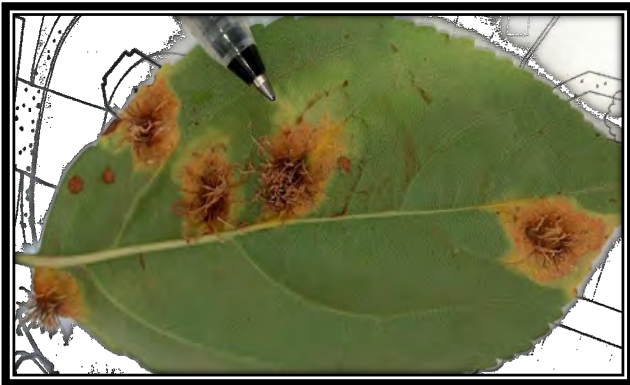
**Figure 3: Cedar-Apple Rust on apple leaf.**

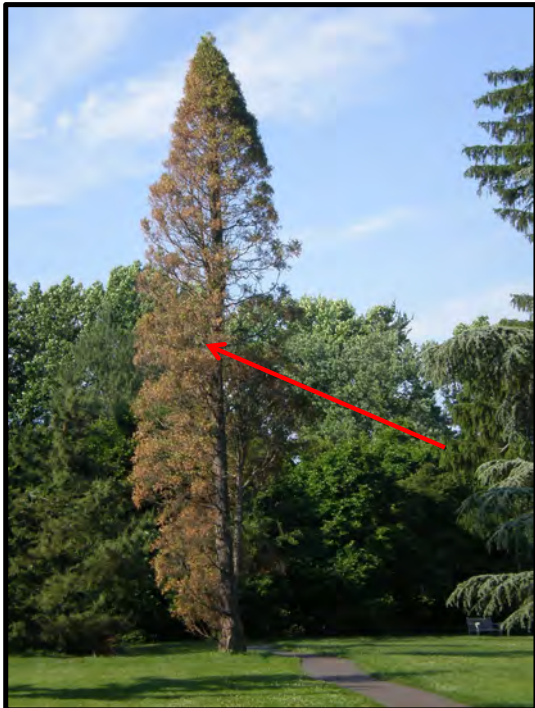
**a3. Seridium canker:** Possible reason for decline of incense cedar #535. The fungus is transmitted by wind-blown spores on rain wetted branches and foliage. Drought stressed trees seem to be the most susceptible.

**Image # 4 – The Incense cedar (*Libocedrus decurrens*) #535 at Marquand Park – This tree lost a major lead within the last two years. There is a significant cavity at the base of the tree. It has browned out very quickly this spring and there appears to be little chance for recovery. It is not a particularly hazardous tree at this point but it is unsightly and has been deemed “CR” for Consider Removal.**

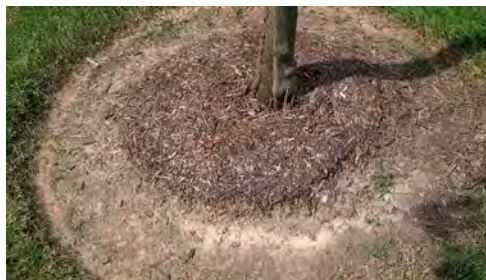
***Image #6 - Mowers wore away the edge of the mulch circle around the tree.***

Mower-induced wounds will have a subtle but cumulative negative effect to tree health because the cell layer where new growth occurs is compromised. This damage must stop to help assure that trees are long-lived and remain vigorous.

To help alleviate this type of damage, remove as much of the turf as possible around the tree's base and either leave it as bare soil or replace it with good quality mulch. Removing the grass around the tree's trunk will make mower/string trimmer operators' job easier and will remove their reason to get close to the tree's trunk. Also, since grass competes with tree roots for resources, turf removal will have the added benefit of promoting tree growth and health.

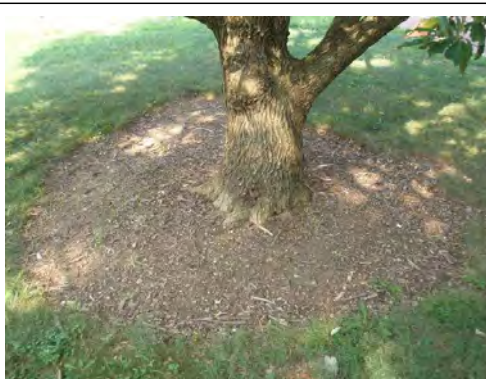
*Image #7 - Tree root area showing mineral soil after dead grass decomposes*

To remove turf around trees, spray the area with Roundup® or Rodeo® (chemical compound: glyphosate) or their equivalent around the base of trees in lawn area so that it is unnecessary for mowing equipment to get close to the tree's trunk flare. Larger areas are recommended around trees with surface roots that are susceptible to damage from mowers. **Care should be taken to avoid spraying the trunk of thin-barked trees, or the trunk, roots, or any suckers arising from the trunk or roots.**

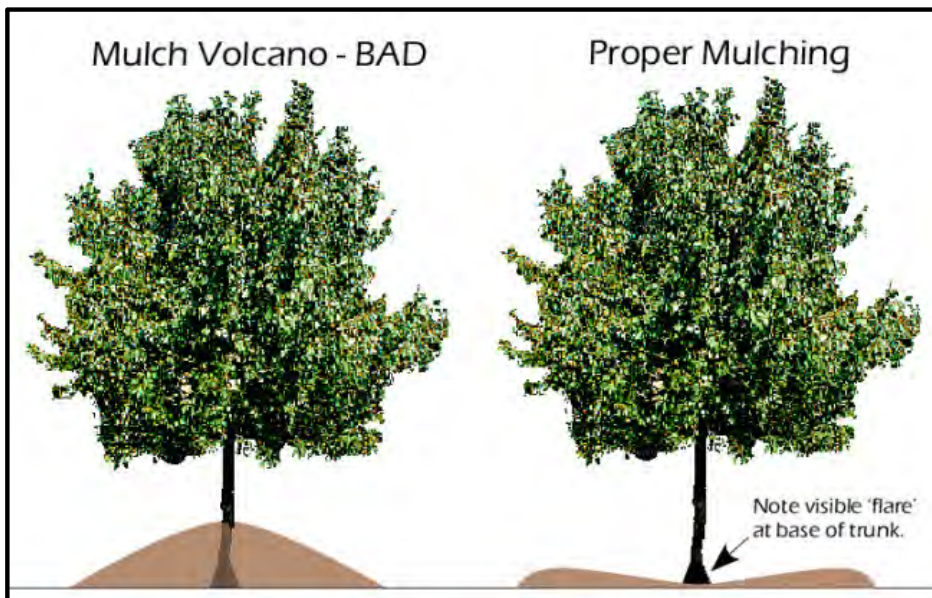
**Image # 9 – Volcano mulching as opposed to proper mulching**

- Large tree roots should not be harmed if the edge of mulch rings is delineated by manually using an edging shovel. If physically defining the edge of the mulch is absolutely necessary, the operator should use their weight and stand on the shovel to penetrate the soil rather than just using their arms to drive the edging shovel blade into the ground. Also, consider the procedure of not cutting into the soil at all, and placing the mulch carefully to define the mulched edge.

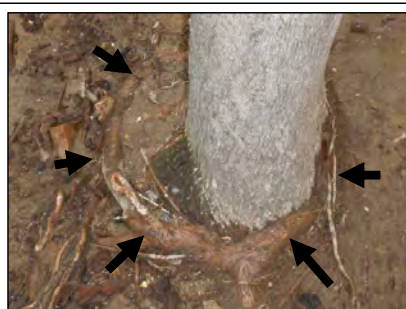
Several trees in Marquand Park were discovered with girdling roots which are not recommended for removal as removing large roots may jeopardize the tree's overall health. More girdling root conditions may exist, but these were not discovered during the field work since they are often hidden from view below ground or are covered by mulch.

Image #8: Girdling Root

Girdling roots usually are formed when the trees are being grown and are caused by nursery and transplanting practices, soil obstructions, and unknown factors. When plants are held in containers for too long a period of time, many roots begin to circle around the edge of the pot (as in Figure 3). These eventually can girdle the tree. Also, girdling roots can be caused by planting in very compacted soil because new roots have difficulty growing out of the planting hole and into the surrounding compacted soil. Roots can circle the bottom and sides of the planting hole, not unlike those growing in an undersized container. This may be an issue for trees in Marquand Park because of compacted soil conditions.

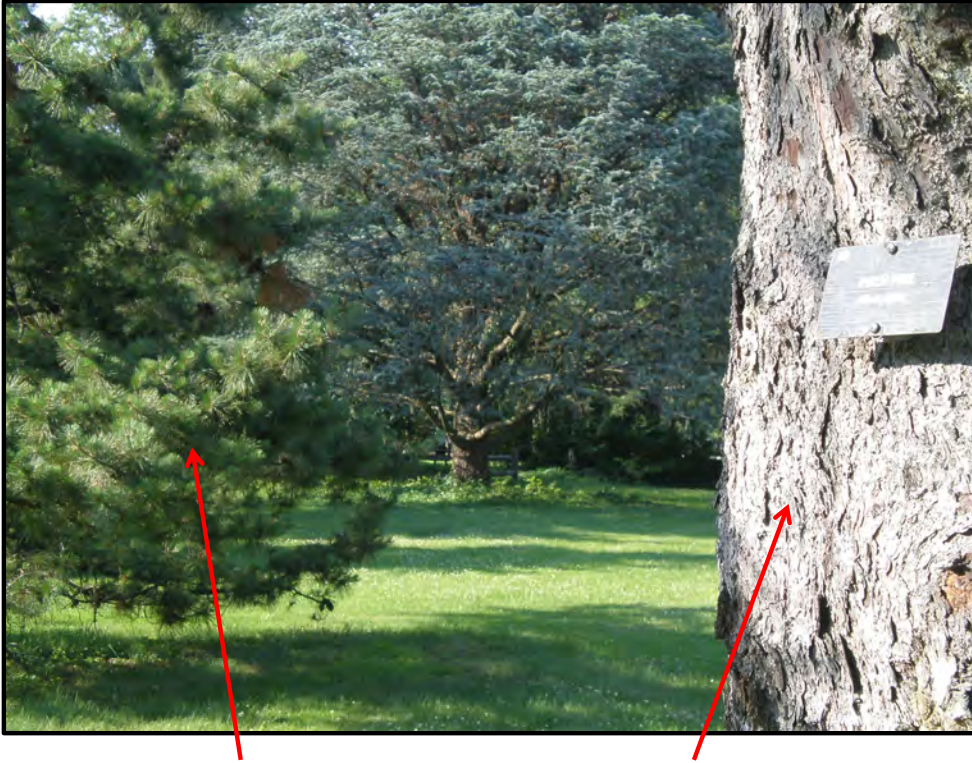
**Image # 12 – *Pinus rigida* #538 sign attached to the trunk of *Picea abies* #539**

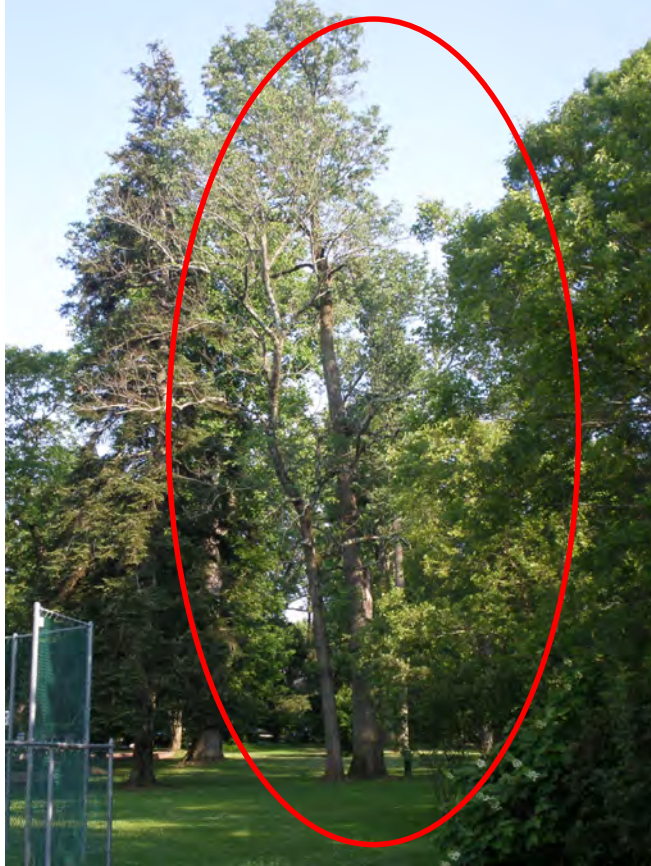
- Make arrangements for the immediate removal of the two white ash (#613 & 614) near the play areas in front along Lover's Lane. These two trees are identified as being particularly hazardous and are included in the list of nine trees recommended for immediate removal.

**Ash # 613 & # 614 to be removed**

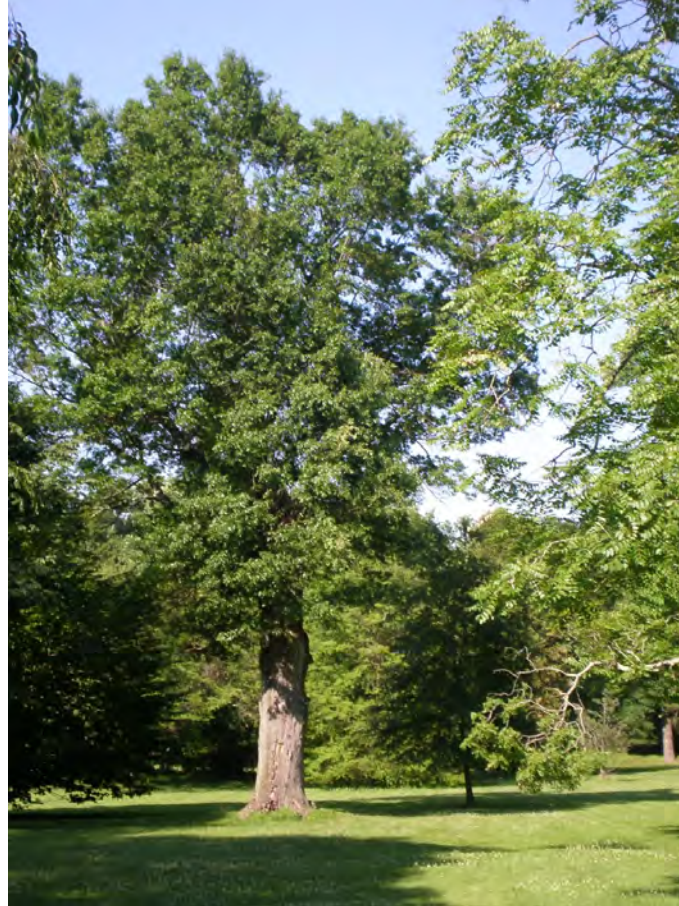
**Willow oak # 485 to be removed**

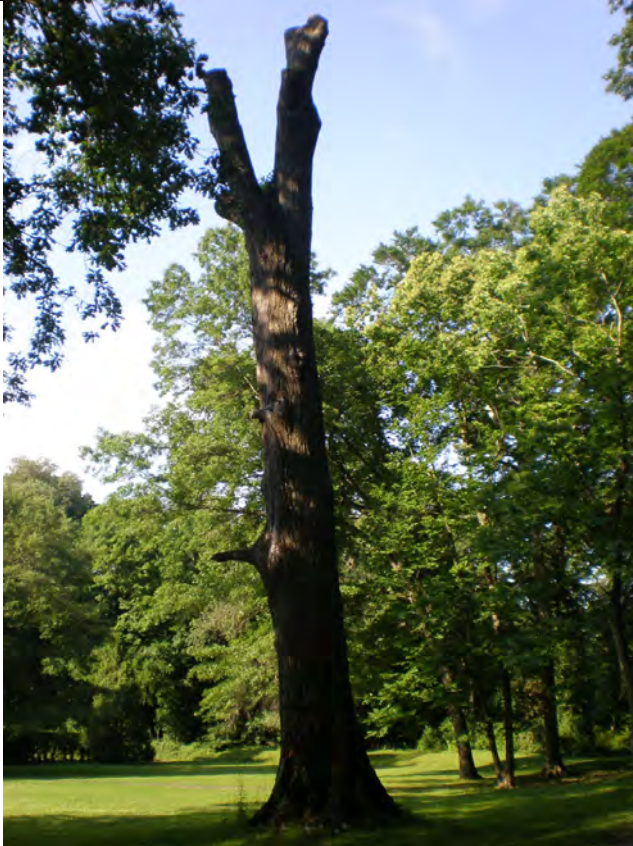
**40' Red oak stick #466 to be removed**

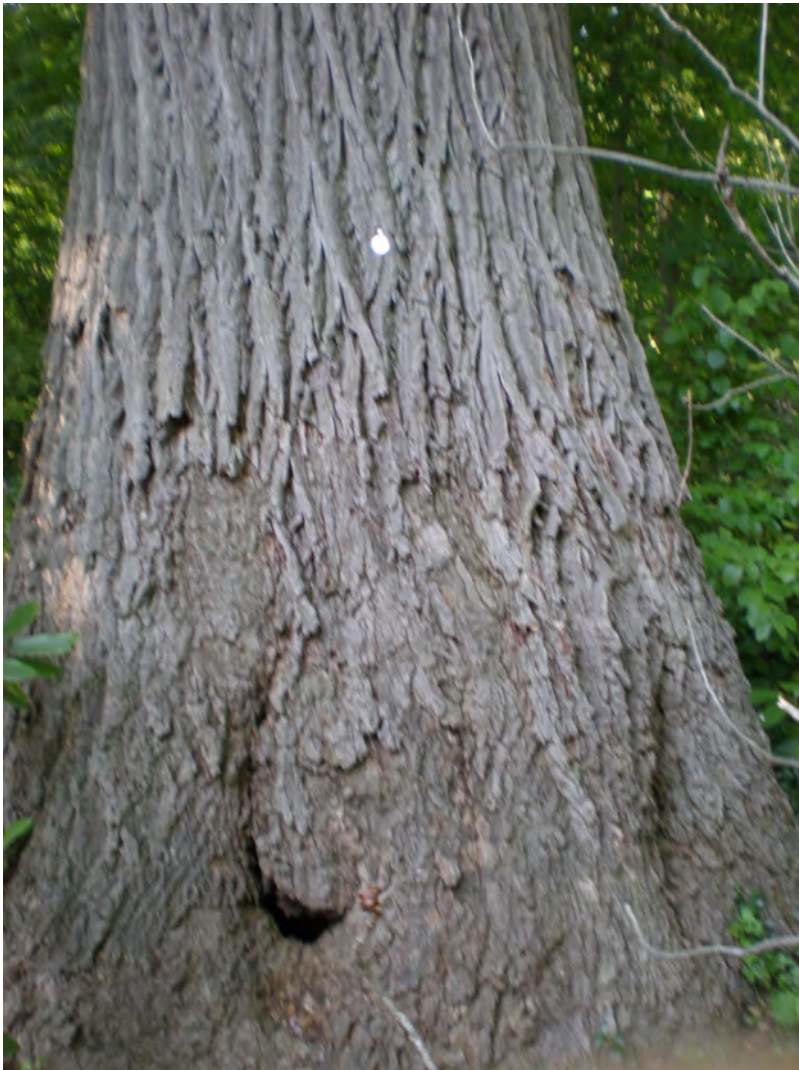
**Tulip polar # 189 with basal cavity – need to inspect further**

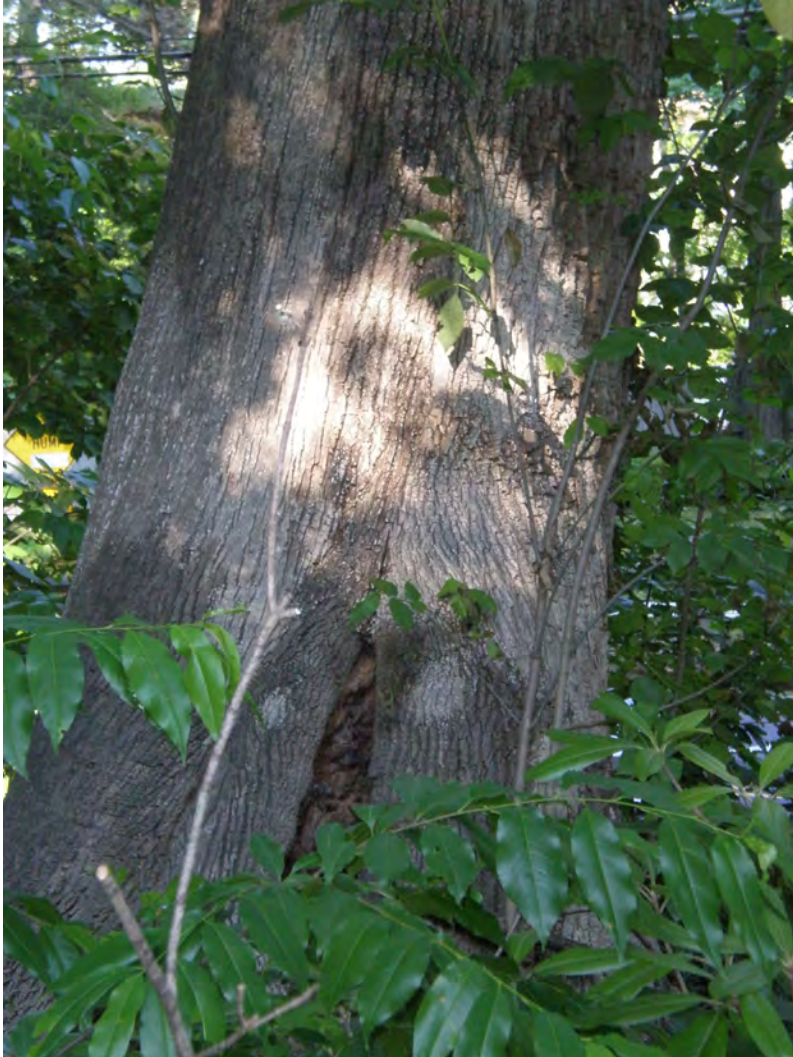
**Base of white ash # 190 with leaning over Mercer Road**

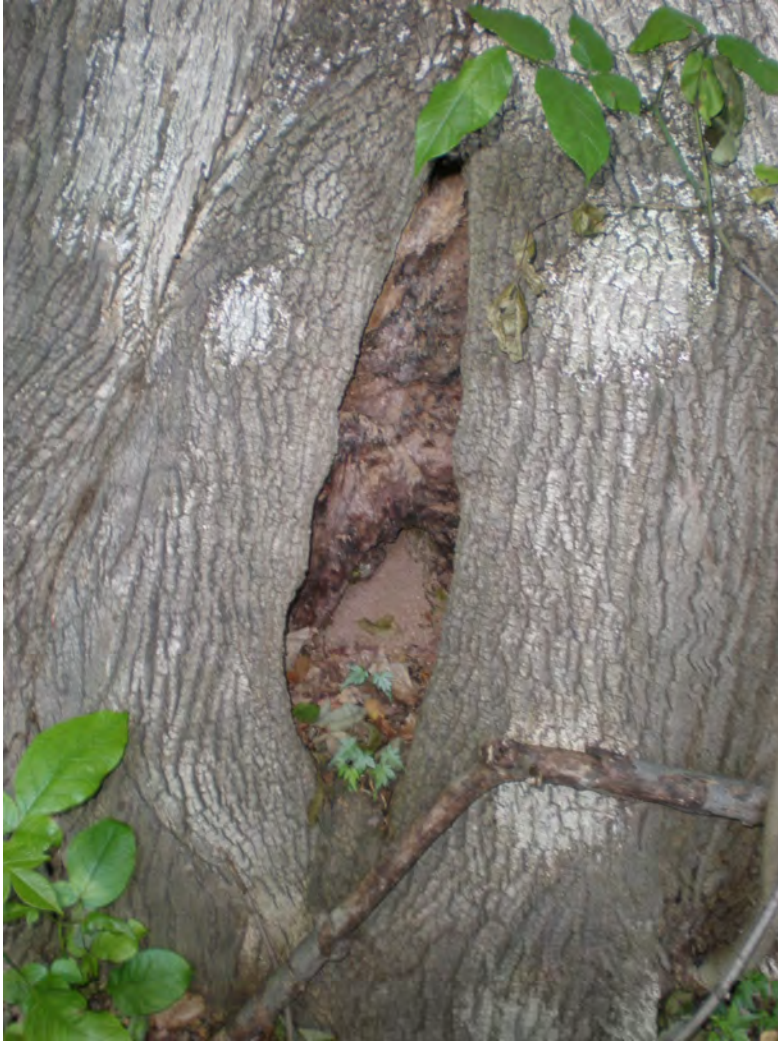
**Large basal cavity of ash # 190 – Needs further inspection**

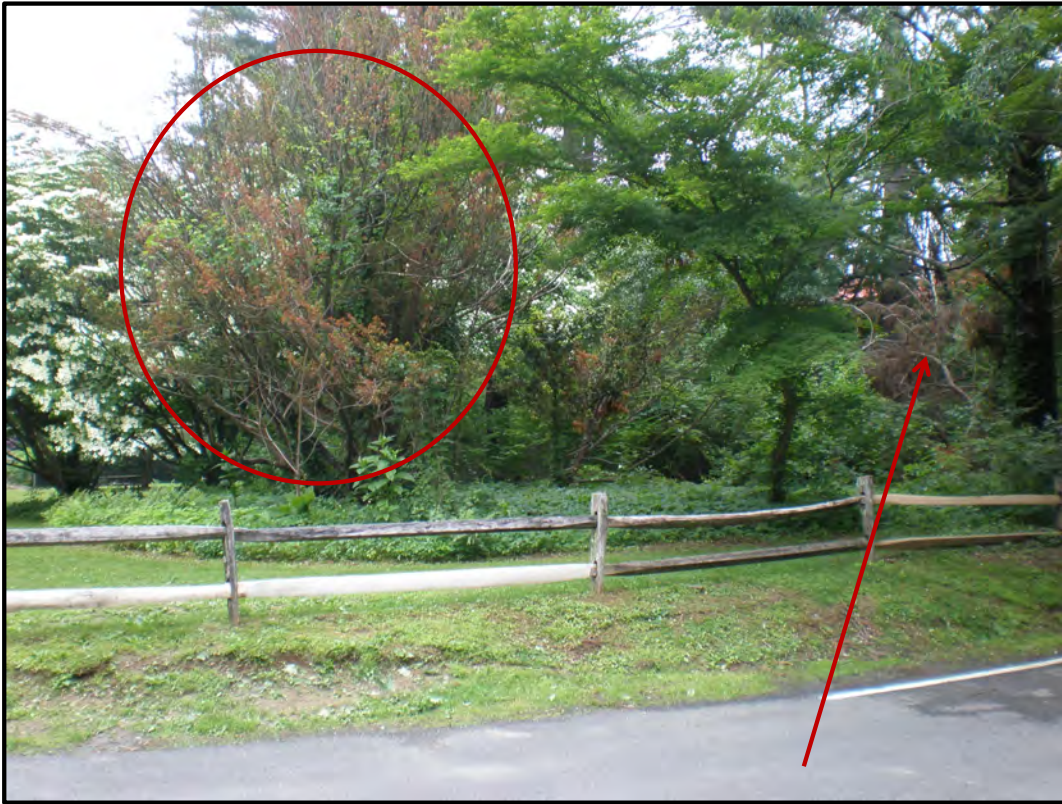
Dead Taxus # 683 near parking lot white pine brush on the ground behind it is from the neighbor's tree

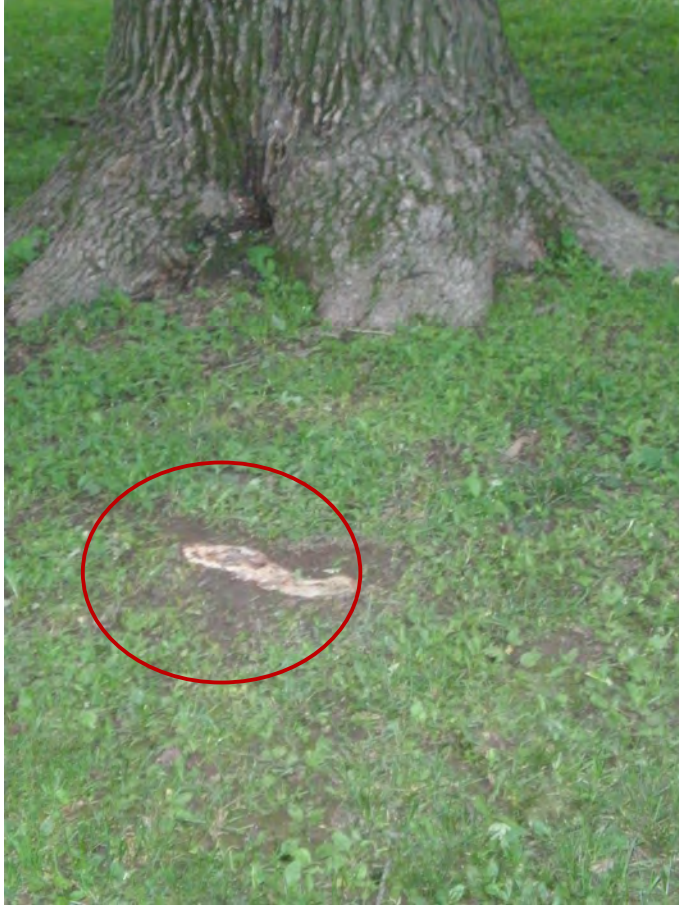
**Recent Mower Root Damage to Norway maple # 616**

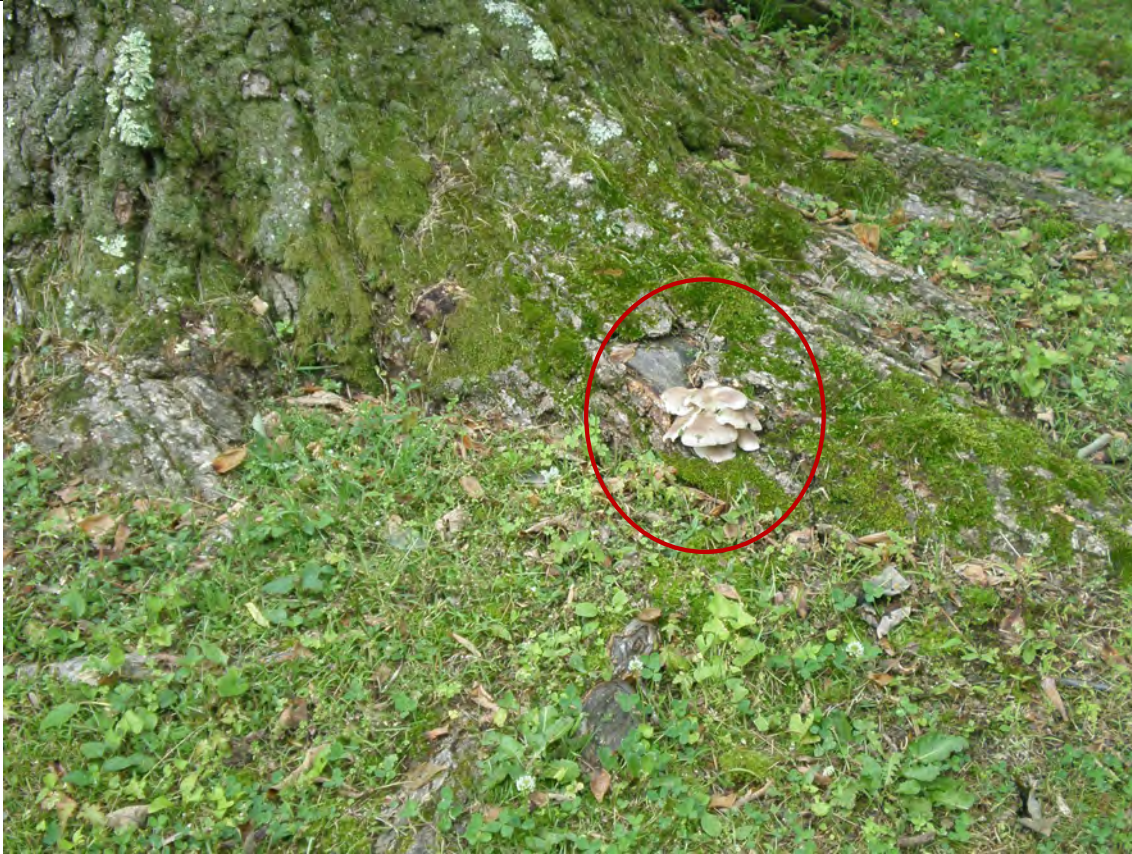
**Tulip poplar # 624 near playground – has a 134” Circumference at Breast Height — has a 20’ dead top and is in decline – life expectancy of less than five years because of damage from mowers**

**Fungal fruiting body from a white rot root and butt rot fungus that has gained entry into the tree through multiple scars at base from Mower Root Damage and Mower Trunk Damage**

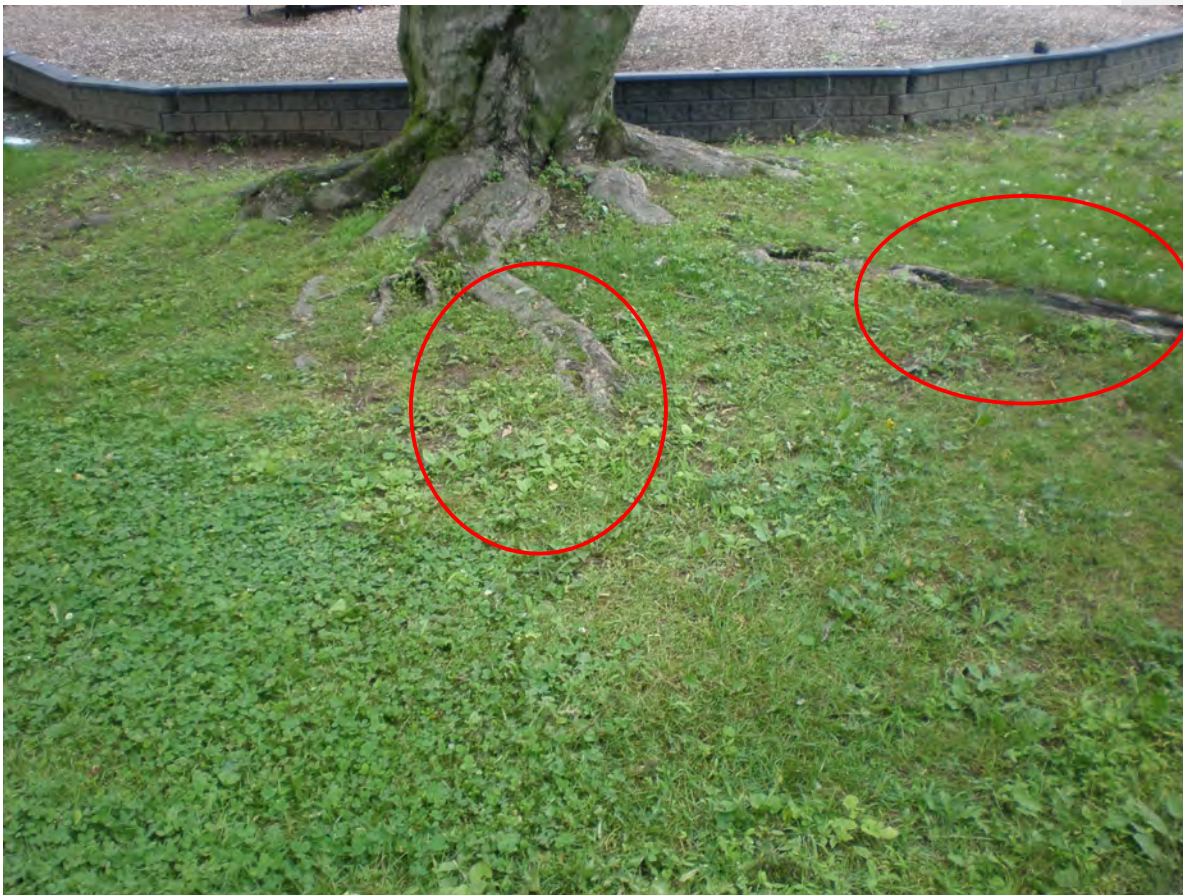
**This is the basal area of Japanese maple # 624 that has multiple examples of surface roots that have been repeatedly damaged by mowers. This tree is now in decline**

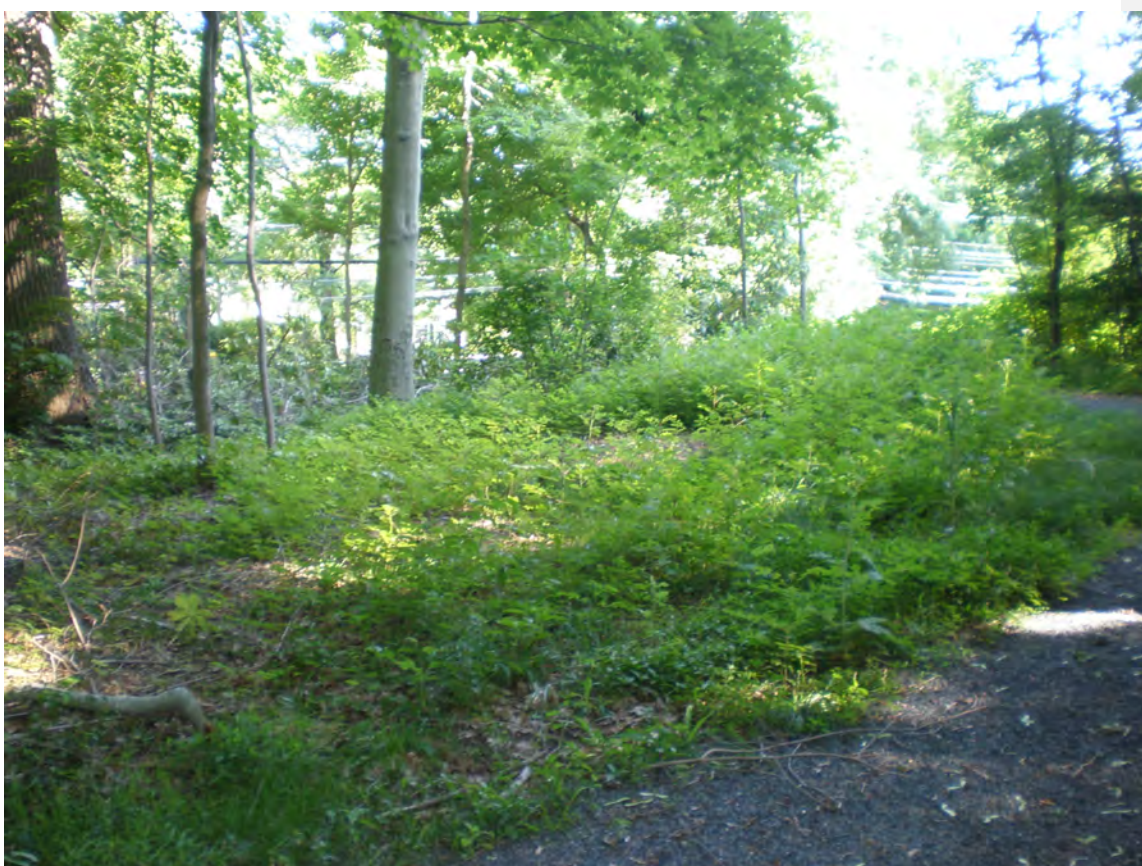
**Fresh example of Mower Root Damage**

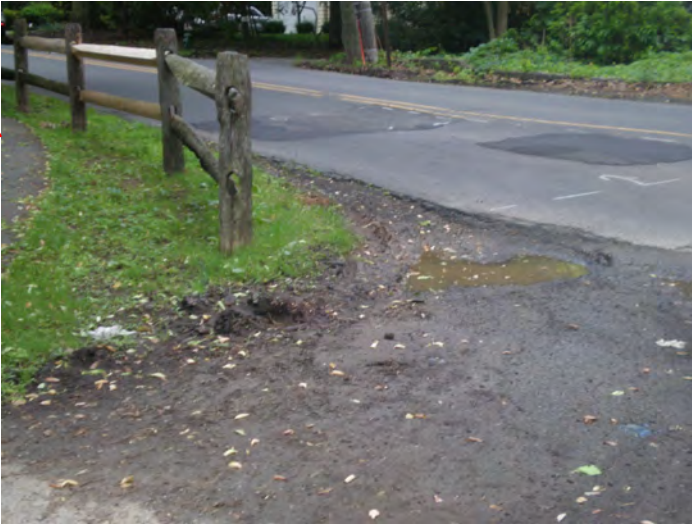
Paved entrance to the Park is in disrepair and needs to be attended to

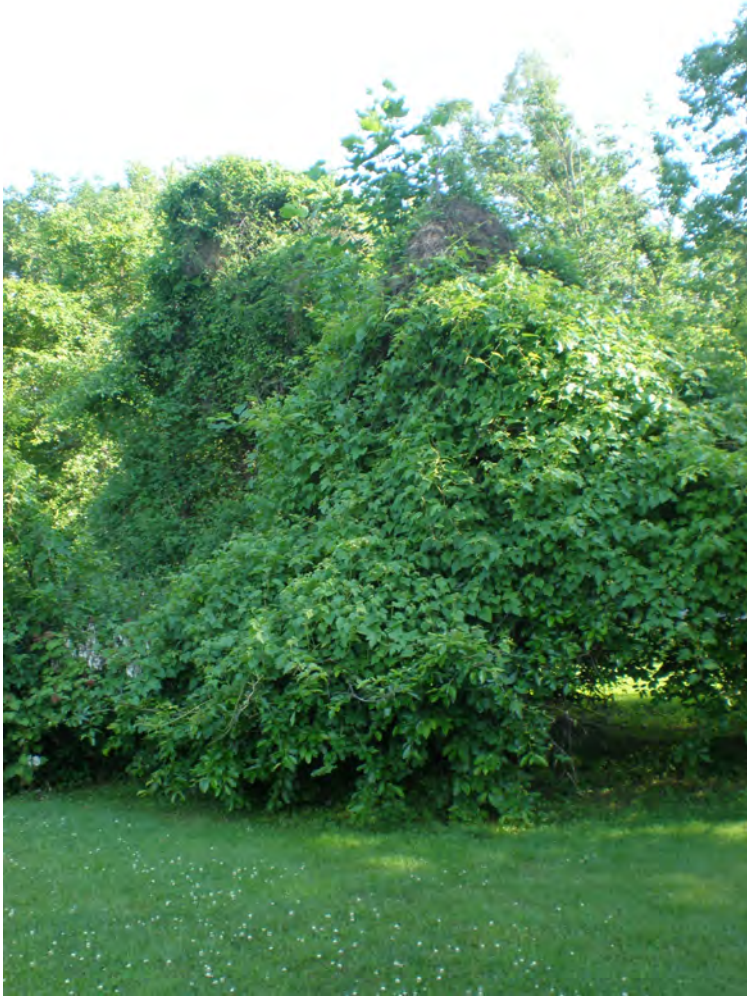
**Invasive vine growth is gobbling up much great plant material**
