Municipality of Princeton
Preliminary Investigation Report
Non-Condemnation Area in Need of
Redevelopment
Block 31.01, Lot 105 and Block 7301, Lot 1

Topology, LLC
60 Union Street, 1st Floor
Newark, NJ 07105

Appendix F: Visual Survey Report

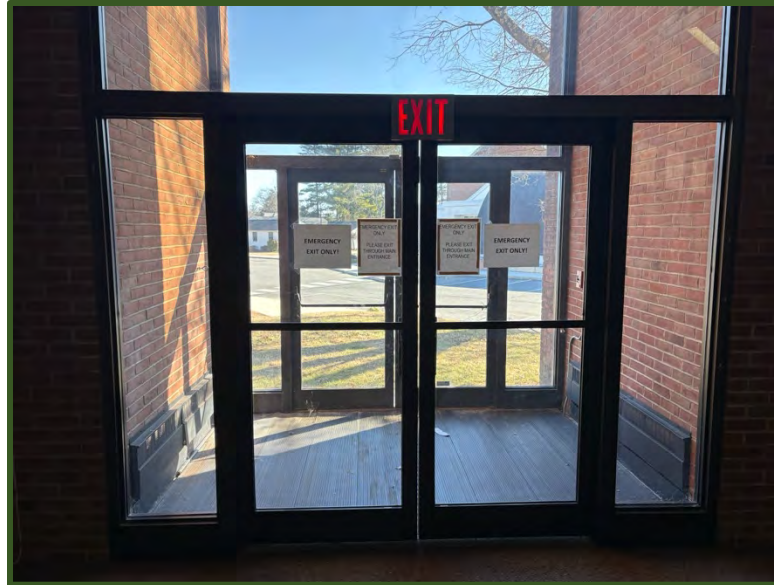
Figure 27: Exit/Entrance stairs which depict accessible exit with no sidewalk. Signs read "EMERGENCY EXIT ONLY!"
