Municipality of Princeton
Preliminary Investigation Report
Non-Condemnation Area in Need of
Redevelopment
Block 31.01, Lot 105 and Block 7301, Lot 1

Topology, LLC
60 Union Street, 1st Floor
Newark, NJ 07105

Appendix F: Visual Survey Report

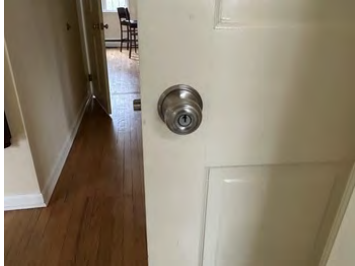
16-3A(j)(1) Windows and Doors: Requirements

The bedroom doors were equipped with locking devices that allow the doors to be locked when the bedrooms are not occupied. This is prohibited by the Housing Code. Replacement of these locks is required.

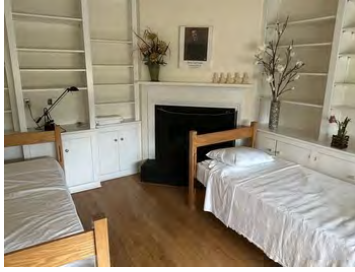
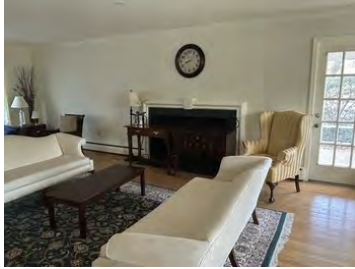
You may choose to seal the fireplaces to prevent their use. The fireplace chimney shall be properly sealed at the top with an approved

chimney cap, screen or similar to prevent vermin, rain, snow and vegetative debris from entering. The chimney damper shall be closed. The base/firebox shall be properly sealed at the hearth by means of framing mechanically fastened, with a non-combustible sheathing or sealed and secured with masonry block.

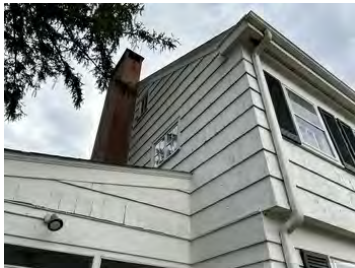
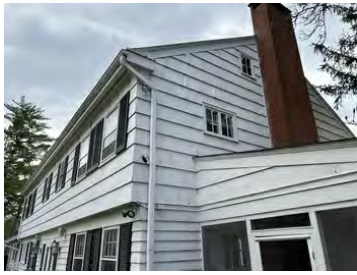
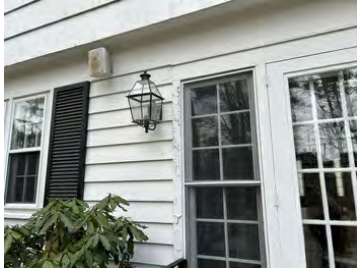
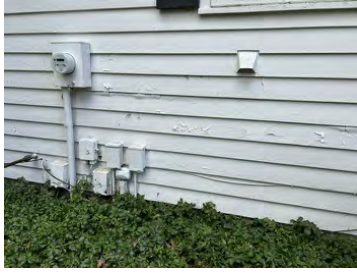
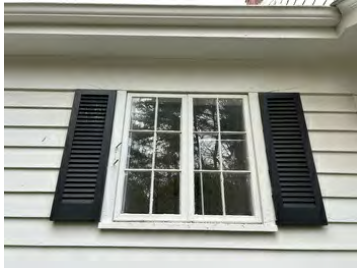
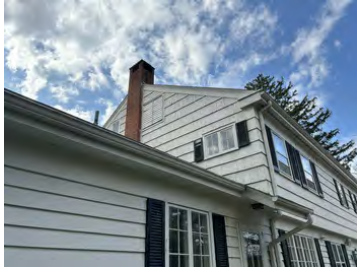
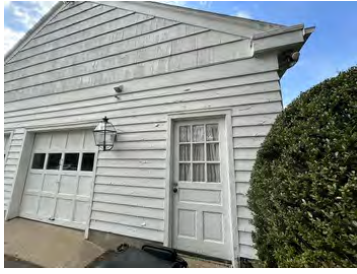
Chipped/peeling paint - Deteriorated paint, chipped, and/or peeling paint observed on exterior areas of the siding, window and door trim, entry and garage doors, and windows (wells/jambes/muntins). This is a lead paint hazard and requires repair.

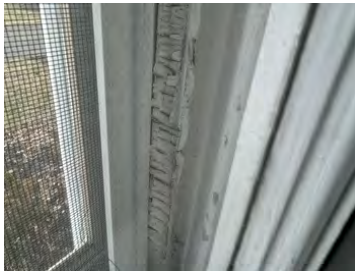
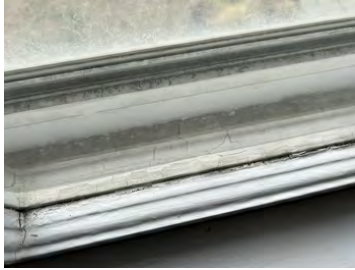
Interior

Chipped/peeling paint on interior

Chipped/peeling paint - Deteriorated paint, chipped, and/or peeling paint observed on interior areas of windows (sashes/sills/muntins). This is a lead paint hazard and requires repair.

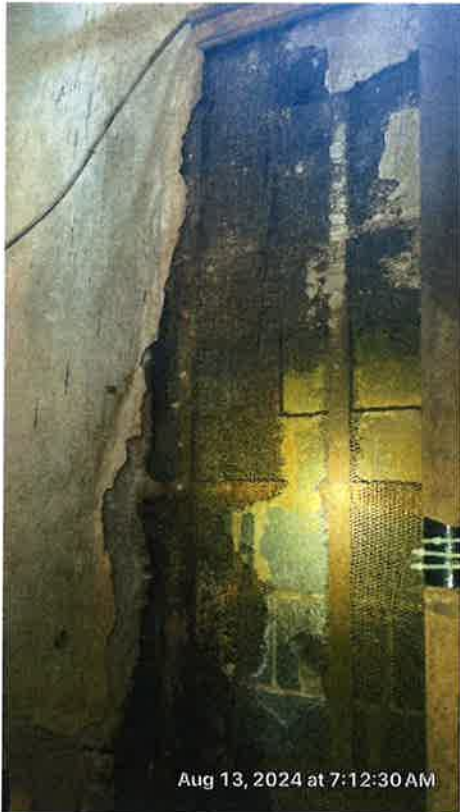
1

Williamson boiler room - SD wall plaster

All SD materials should be repaired. If the material is ACM or assumed to be ACM, that repair work should be conducted by a New Jersey licensed asbestos abatement contractor.

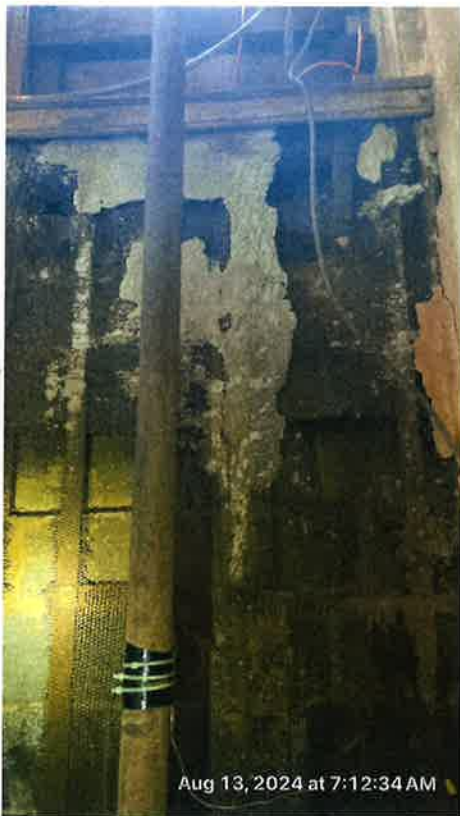
2

Williamson boiler room - SD wall plaster

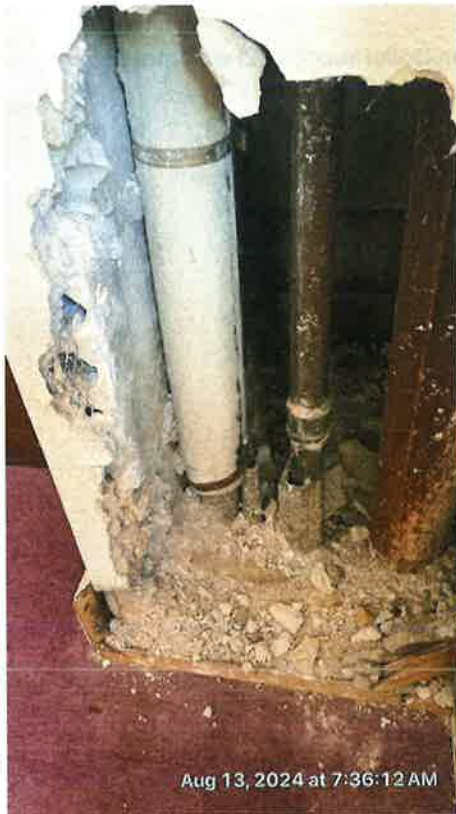
Additionally, there was a hole in the plaster in room 3 on the second floor. This was considered as localized SD material. The total quantity of SD plaster in this room equals approximately 8 SF. The visible pipe insulation inside the wall was also damaged, but not SD.

Williamson 2F Room 3 - SD wall plaster

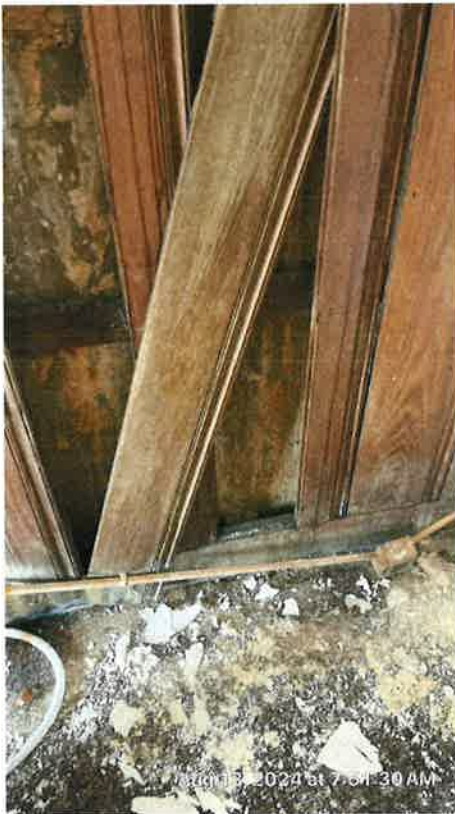
2

Taylor 2F office next to steam room - SD wall plaster

EWMA also recommends, once the classification of the building materials in Taylor Hall has been determined, that a proactive approach be utilized to mitigate any future building material deterioration.

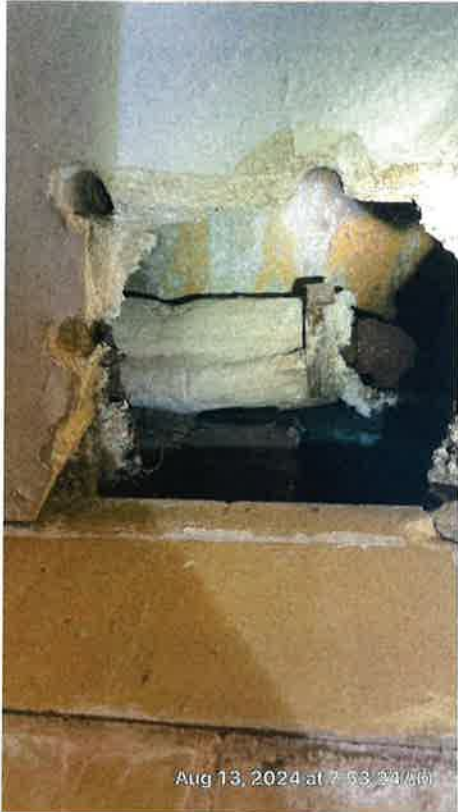
3

Taylor 2F bathroom - SD pipe insulation and plaster

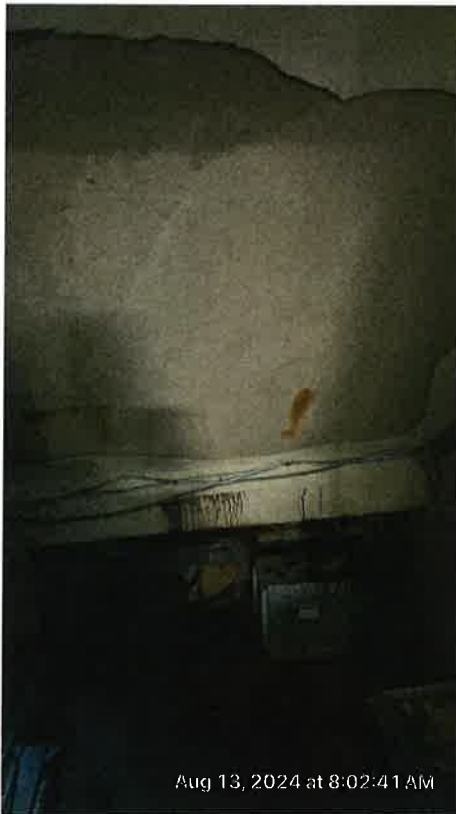
4

Taylor 1F steam room - SD wall plaster

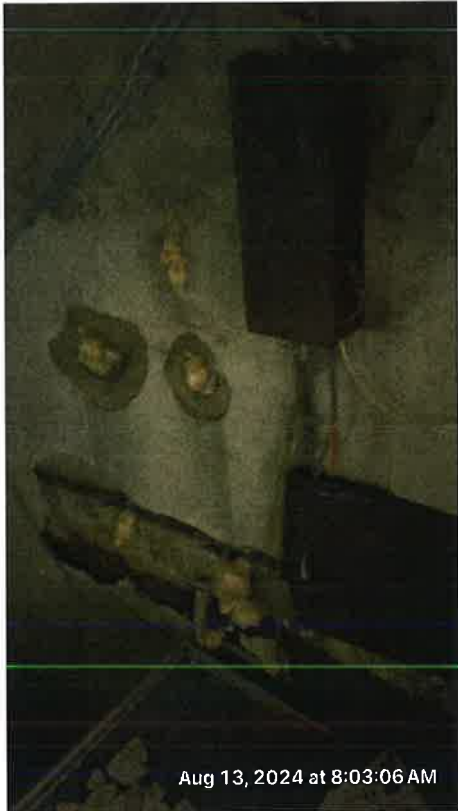
5

Taylor 1F steam room - SD wall plaster

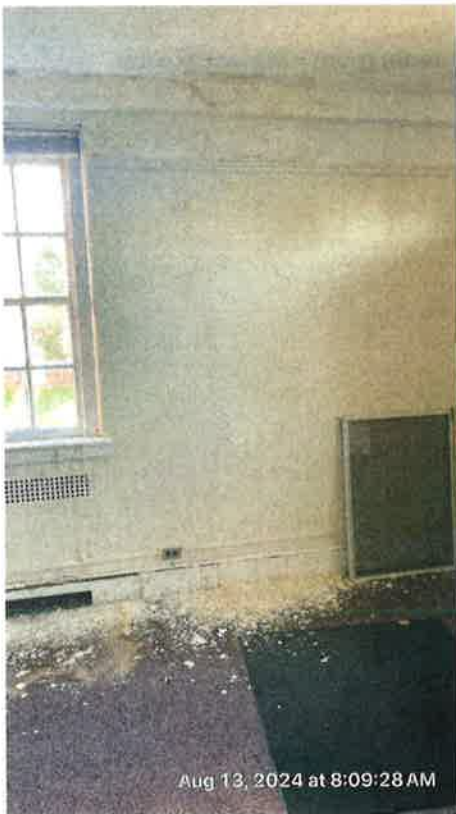
6

Taylor - SD 1F plaster

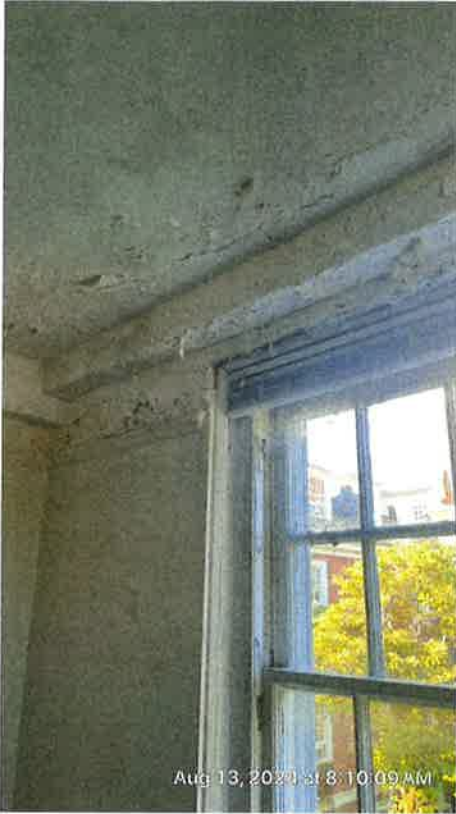
7

Taylor - 2F room

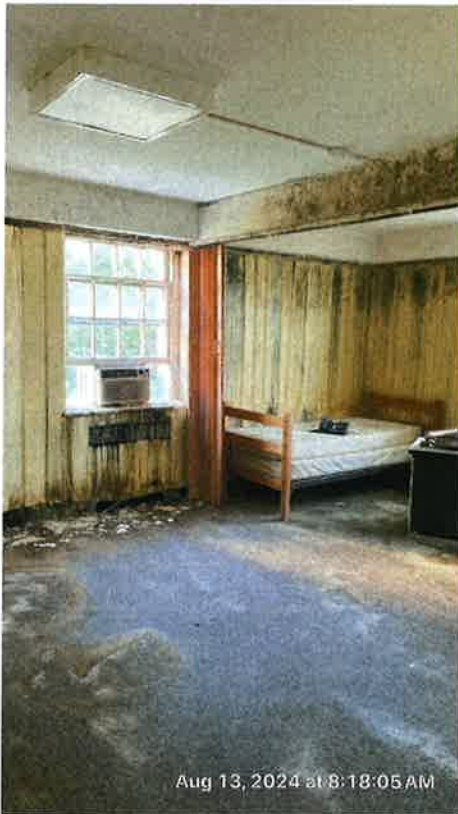
8

Taylor 1F bedroom - SD plaster (localized)

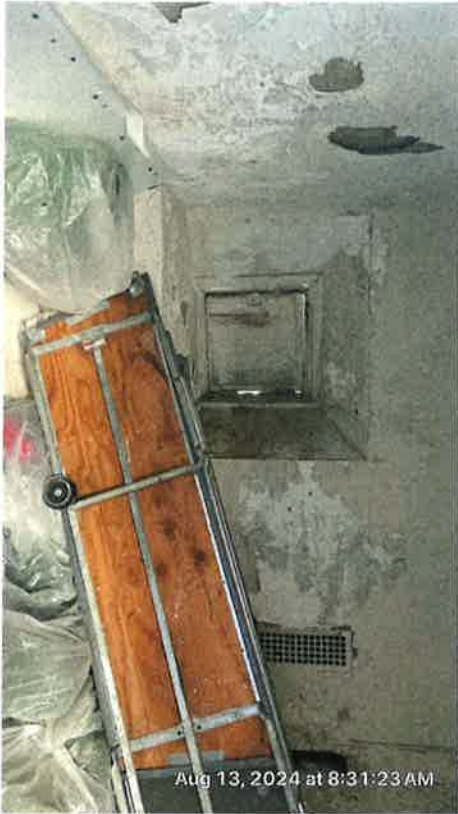
1

Bristol 2F storage closet - SD plaster

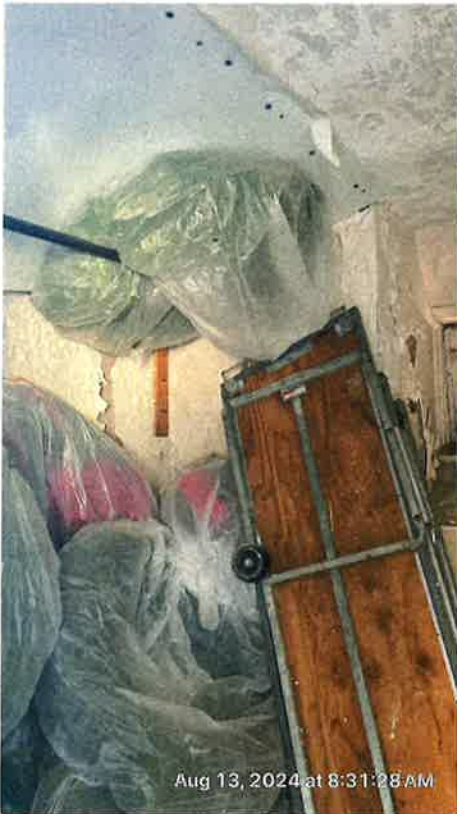
2

Bristol 2F storage closet - SD plaster
